Comprehensive Field Evaluation of Asphalt Patching Methods and Development of Simple Decision Trees and a Best Practices Manual

Department of Civil Engineering
University of Minnesota Duluth

June 2017

Research Project
Final Report 2017-25

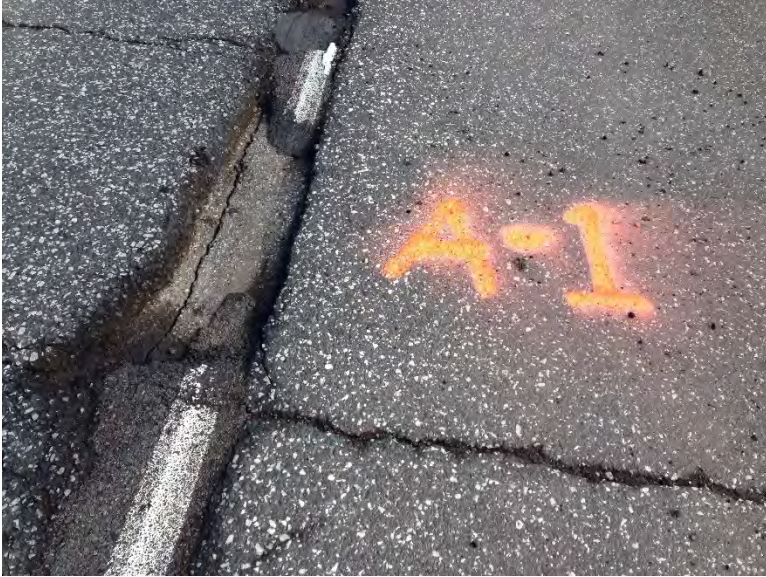
Figure 3.1 Pothole A-1 prior to Patching (After Cleaning).

Pothole A-1: This pothole was located along the shoulder joint of the roadway. The pothole lies in between two reflective transverse cracks and has a longitudinal crack running along the bottom of the pothole as shown in Figure 3.1. The pothole was prepped by sweeping the area. The size of the pothole was 40 inches x 14 inches x 2 inches.

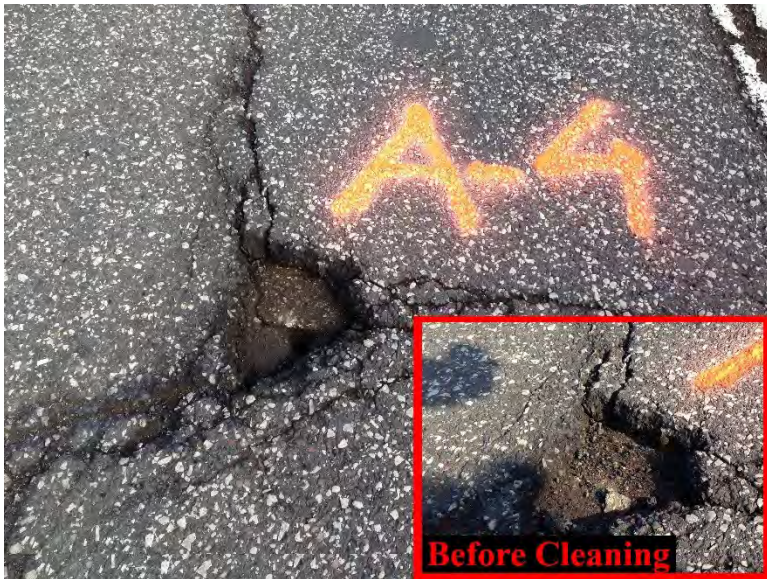
Figure 3.4 Pothole A-4 prior to Patching (Before and After Cleaning).

Pothole A-4: This pothole was located in the non-wheel path of the driving lane. The pothole exists at the intersection of a reflective longitudinal and transverse crack as shown in Figure 3.4. The pothole was prepped using compressed air. The size of the pothole was 10 inches x 10.5 inches x 1.5 inches.

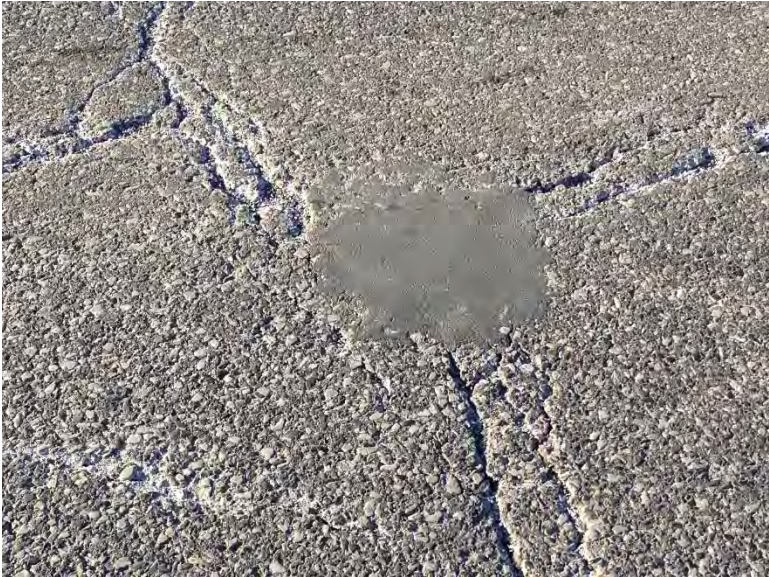
Although the cold mix patches had a hard compacted layer on the top of the patch, underneath that layer was pliable material that still had an oily shine consistent with the day the pothole was patched. Based on the last visit conducted on December 4, 2014, the conditions of the patches were found to be somewhat similar to the previous visits. The only noticeable difference was some abrasion on the patch material from snow plow blades. This abrasion was most noticeable in patch A-4 (Figure 3.19). Also on

Figure 3.19 Pothole A-4 (240 days after installation) with Snow Plow Abrasion.

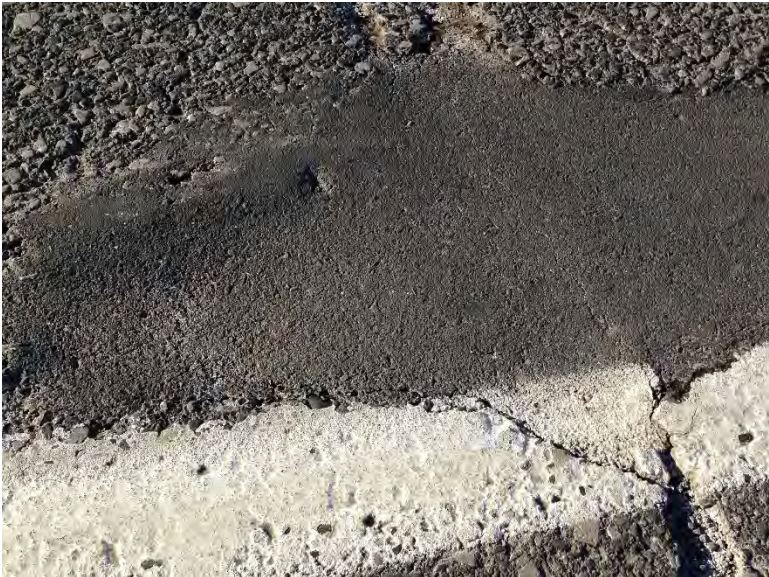
December 4, 2014, it was observed that the pothole A-5 experienced a significant depression in the material since the last visit, as well as some material loss near the bottom of the patch (Figure 3.20).

Figure 3.20 Pothole A-5 (240 Days after Installation).

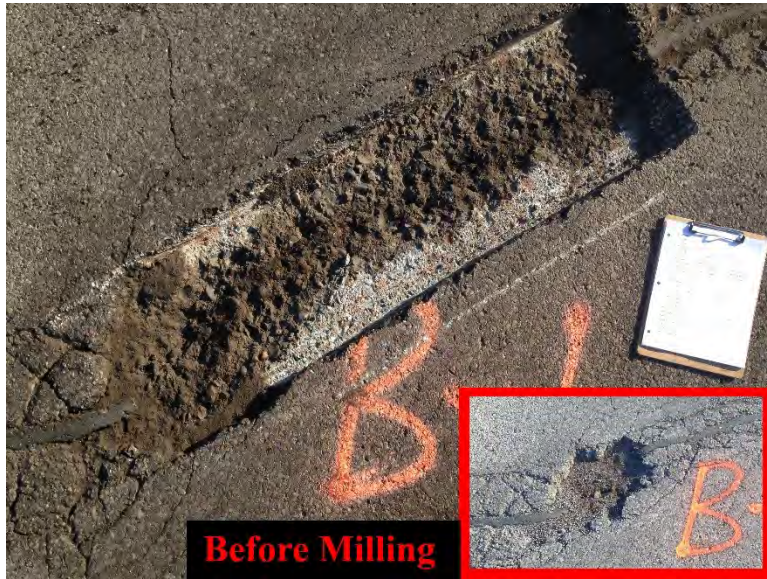
Pothole B-1: This pothole was located in the wheel path of the driving lane. The pothole lied along a large longitudinal crack with alligator cracking. The pothole was prepped with compressed air. The size of the pothole patch was 57 inches x 16 inches x 2.5 inches.

Figure 3.25 Pothole B-1 before and after Milling.

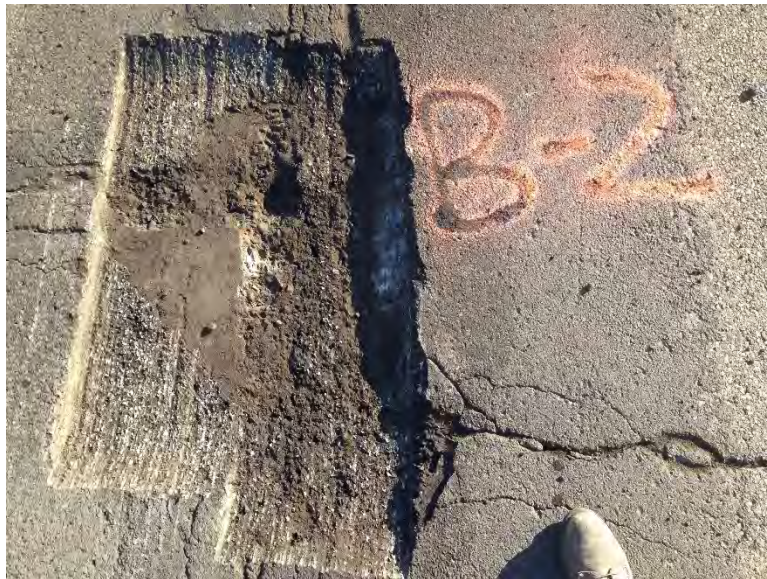
Pothole B-2: This pothole was located in the wheel path of the driving lane. The pothole lied along a large longitudinal crack with alligator cracking. Two transverse cracks ran through the pothole location. The pothole was prepped with compressed air. The size of the pothole patch was 45 inches x 30 inches x 3 inches.

Figure 3.26 Pothole B-2 after Milling.

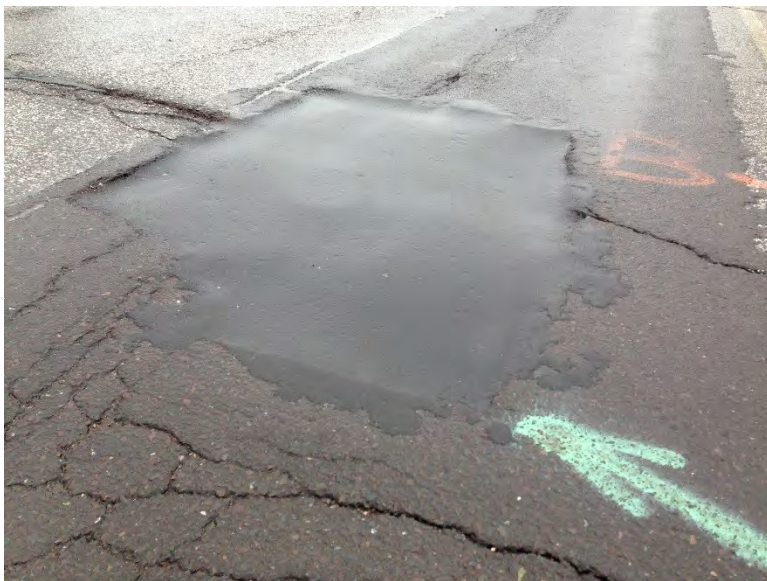
One of the main concerns regarding dishing distresses is the accumulation of water. Pooled water on a roadway provides areas that facilitate hydroplaning during wet conditions as well as icy surfaces in cold conditions (Figure 3.41). Dished areas along patch edges may provide areas for water to infiltrate increasing the deterioration rate of both the roadway and patch material. Dished areas also provide a lower ride quality and potential hazard areas for snow plows.

Figure 3.41 Water Accumulation in Dished Areas of Patch B-3 (18 Days after Patching).

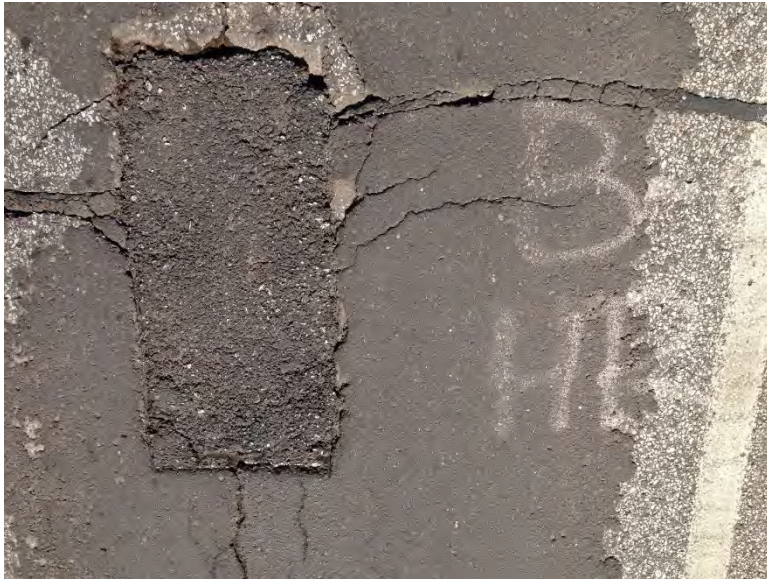
The placement of patch material actually facilitated further damage to the roadway. The damage occurring appears similar to pumping action that is common with concrete panels. As traffic loads travel across the patch area there is not an efficient load transfer causing vertical movement of the patch material. This movement ejects water and fine material from underneath the patch and abrades the adjacent roadway. Comparing Figure 3.43 and Figure 3.44 illustrates that damage to the roadway in Patch B-5. Figure 3.47 provides a close view of this deterioration in Patch B-6.

Figure 3.47 Pothole B-6 (146 Days after Patching).

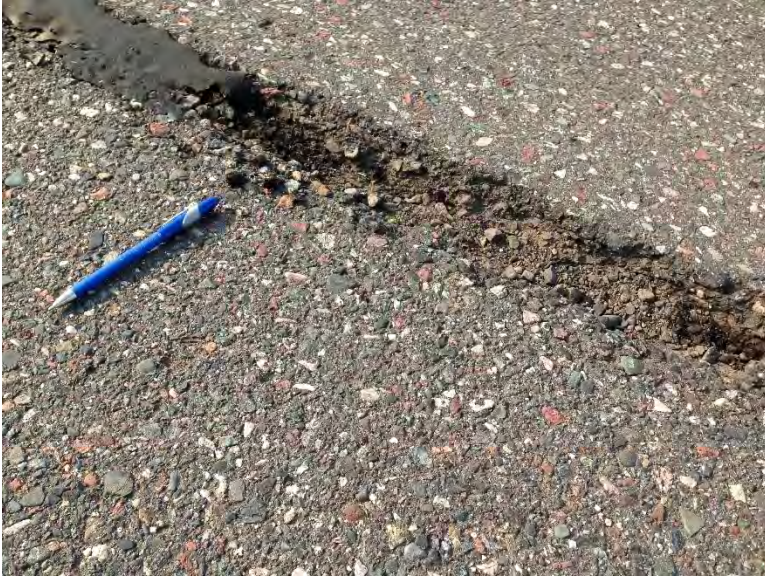
Figure 3.56 Section of Longitudinal Crack with Sealer Missing.

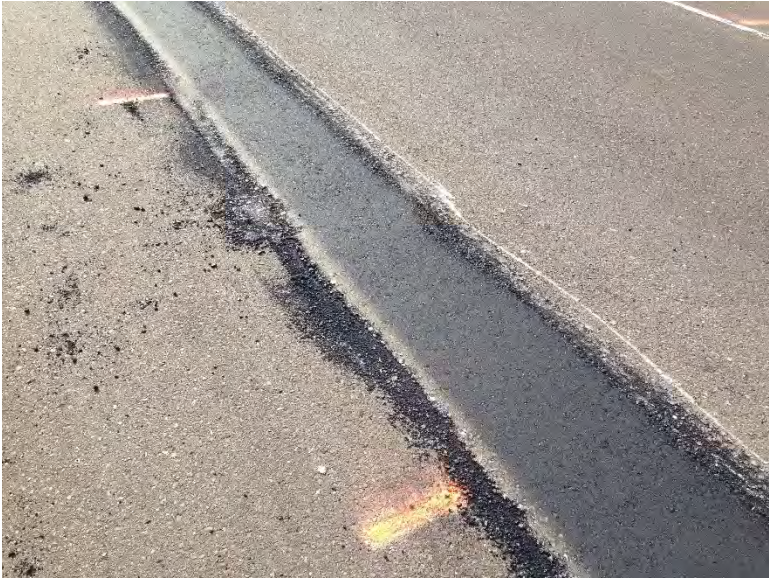
difference between excess material placement (Figure 3.59) and proper placement (Figure 3.60) is illustrated below. Placing the proper amount of material leaves a much cleaner looking product as well as reduces the amount of waste material. Figure 3.61 Shows finished patching work at Pothole D-3.

Figure 3.59 Pothole D-1 after Compaction (Excess Fill Material on Roadway).

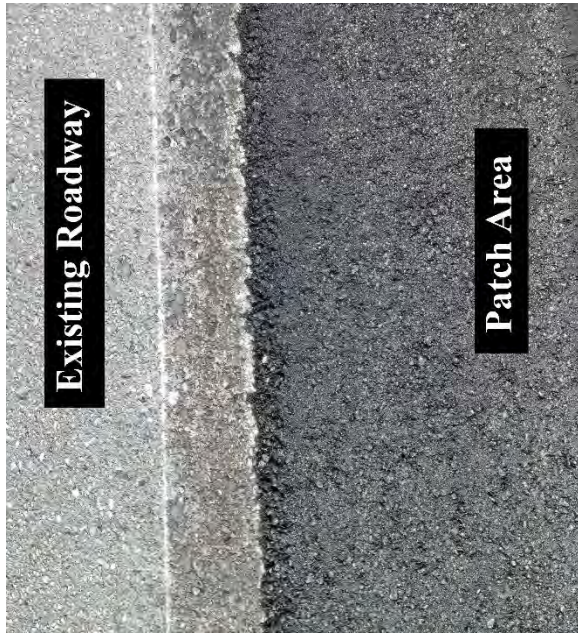
One issue with a mill and fill operation is the compaction along the edge of a patch. A closer look along the edge (Figure 3.62) shows that steel drum rollers, used to compact the fill material, are unable to completely compact the fill material. Since rollers are wider than the patch, the steel drum sits on the existing roadway preventing the compaction of material near the edge. This area of lesser compacted material may lead to a higher rate of water infiltration or patch material raveling.

Figure 3.62 Interface between Patch Area and the Existing Roadway.

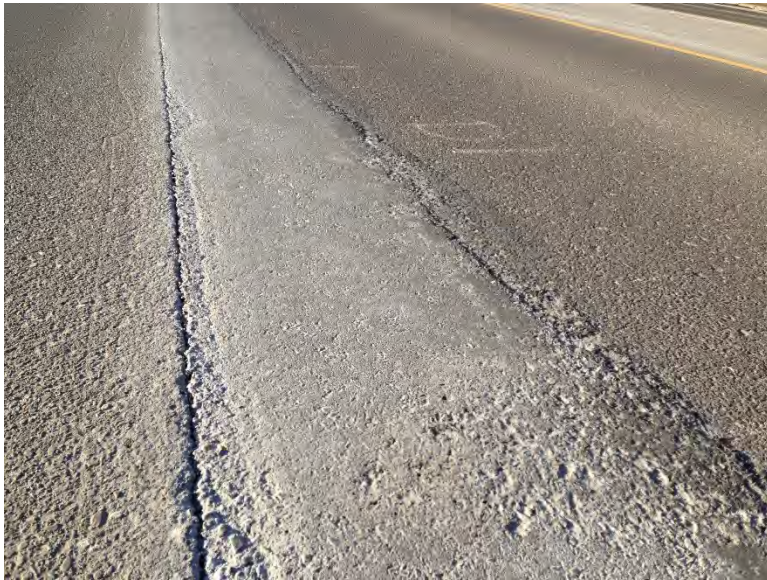
The site visit on December 4, 2014 indicated that Both D-1 and D-2 had significant raveling of material along the interface of the patch and existing roadway (Figure 3.67). It is also shown in Figure 3.67 that some distresses have occurred along parts of the patch surface. The crack running underneath Patch D-3 has propagated through the patch and has a width varying between $\frac{1}{4}$ and $\frac{1}{2}$ inch.

Figure 3.67 Pothole D-1 (126 Days after Installation) with Deterioration along the Patch Interface.

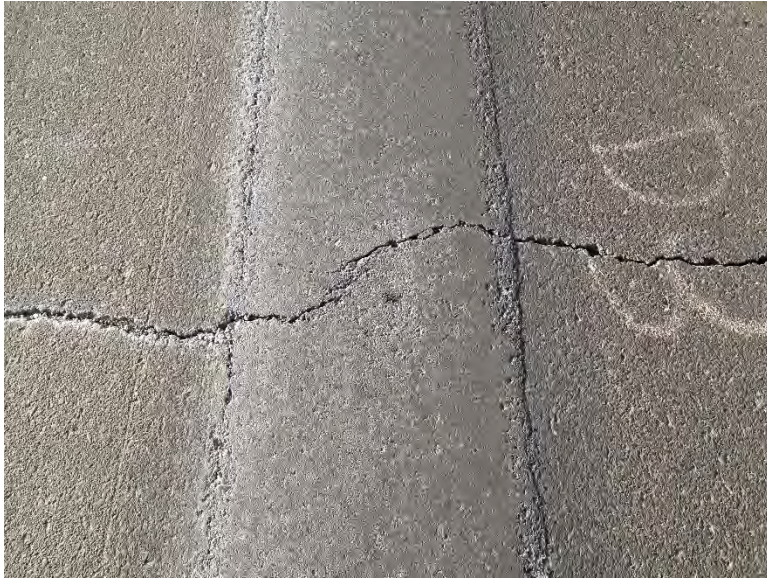
Figure 3.68 Pothole D-3 (126 Days after Installation) with Crack Running Through Patch.

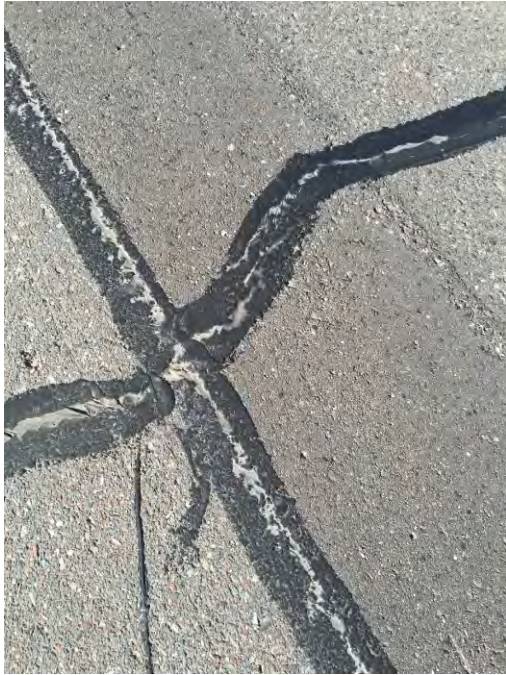
Figure 3.71 Pothole D-3 (446 Days after Installation) with Crack Running Through Patch.

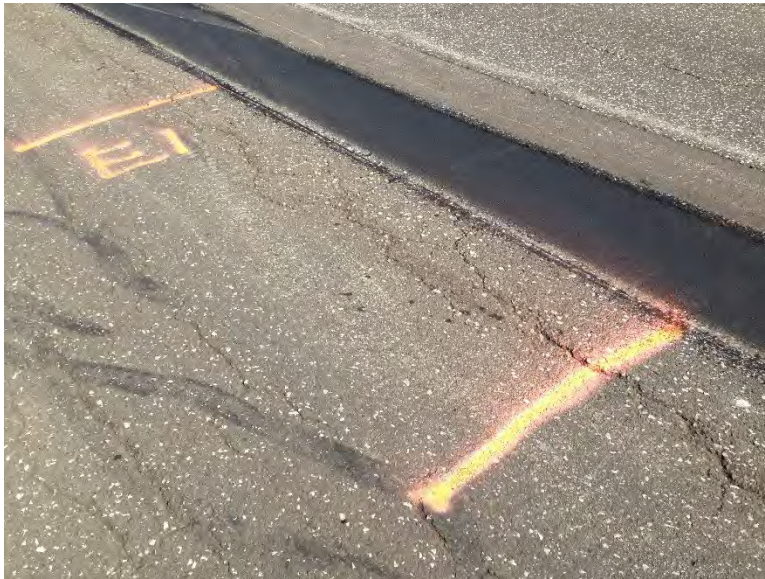
Figure 3.72 Pothole E-1 with Parallel Longitudinal Cracking.

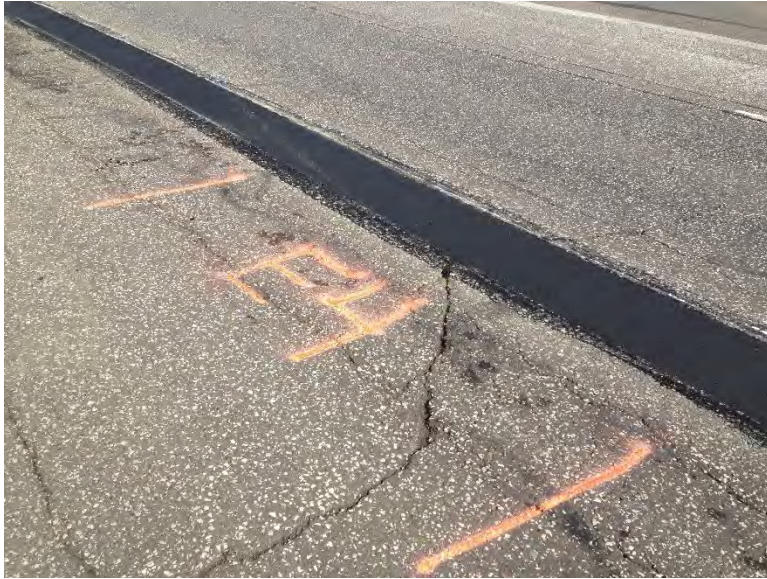
Figure 3.75 Pothole E-4 with Transverse Crack.

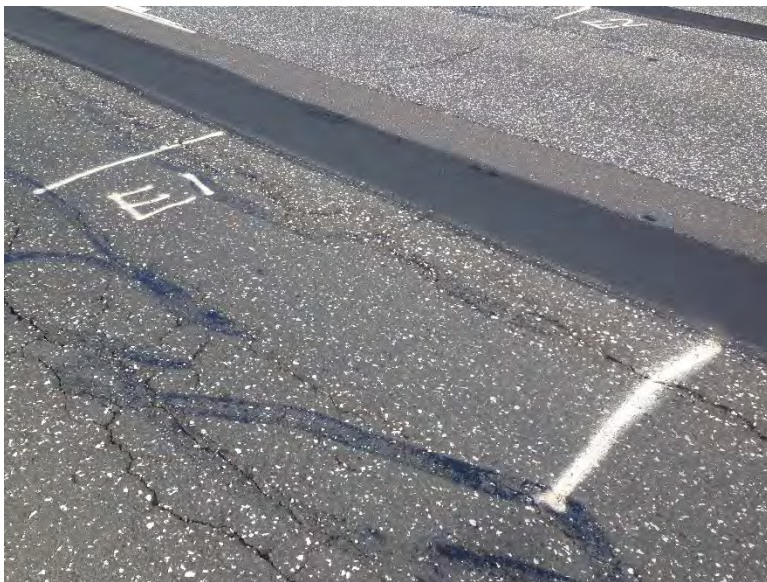
Figure 3.81 Patch E-1 Parallel to Existing Distresses (28 Days after Patching).

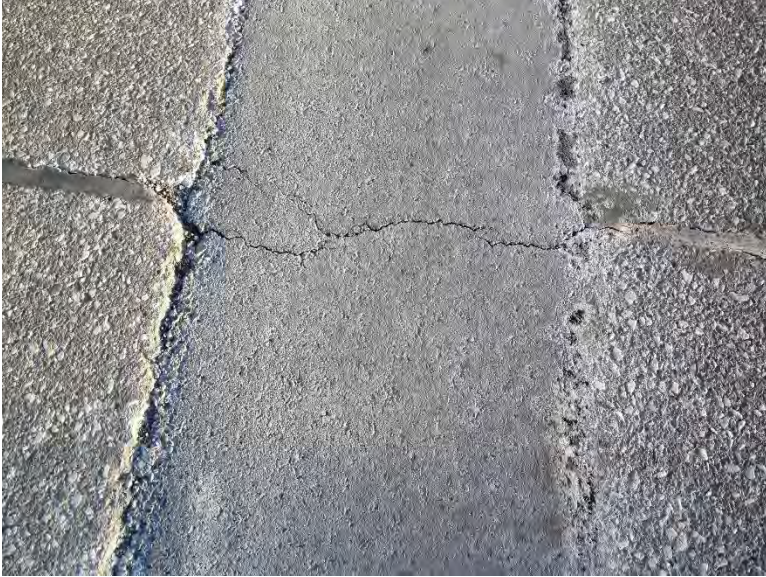
the year was made on December 4, 2014. Figure 3.82 to Figure 3.85 show that a significant amount of damage had occurred to the patch material including cracks and raveling along the patch interface.

Figure 3.82 Cracking of Pothole E-3 (119 Days after Installation).

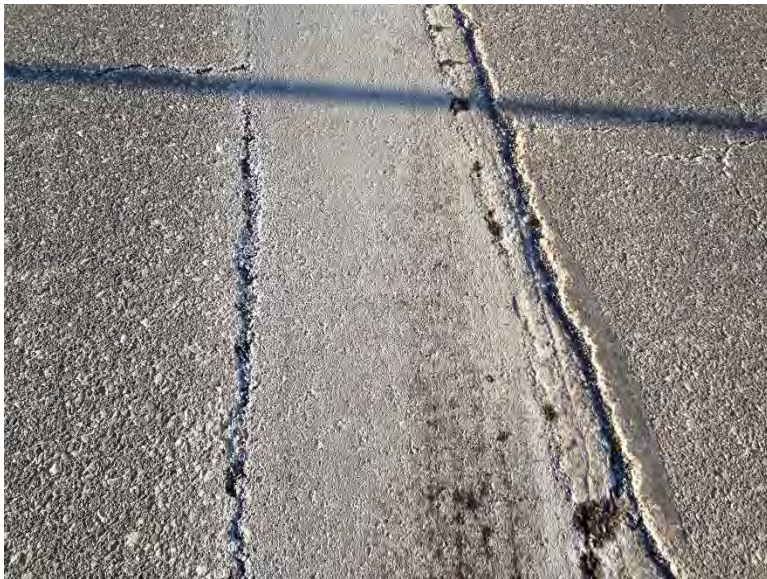
Figure 3.85 Close View of Distresses on Pothole E-5 (119 Days after Installation).
