Comprehensive Field Evaluation of Asphalt Patching Methods and Development of Simple Decision Trees and a Best Practices Manual

Department of Civil Engineering
University of Minnesota Duluth

June 2017

Research Project
Final Report 2017-25

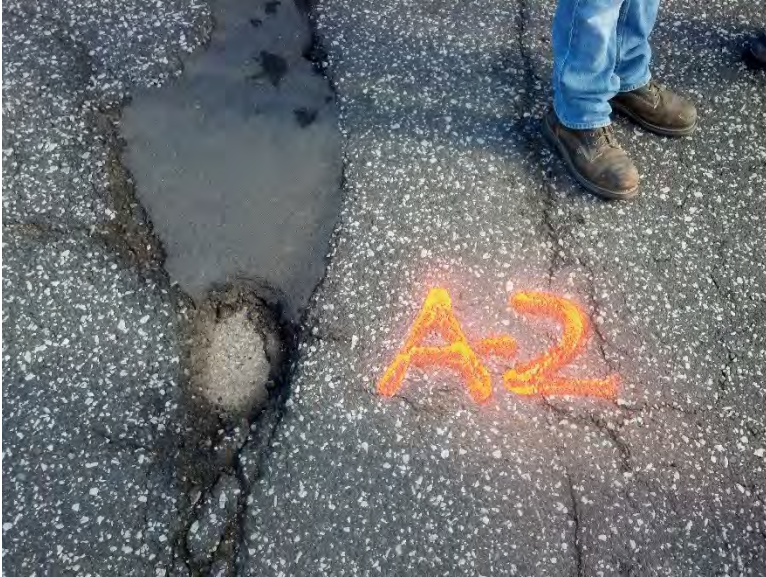
Figure 3.2 Pothole A-2 prior to Patching (After Cleaning).

Pothole A-2: This pothole was located in the non-wheel path of the driving lane. The pothole lies along a large transverse crack with the north face of the pothole being a previously placed patch material as shown in Figure 3.2. The pothole was prepped by sweeping. The size of the pothole was 13 inches x 9 inches x 2 inches.

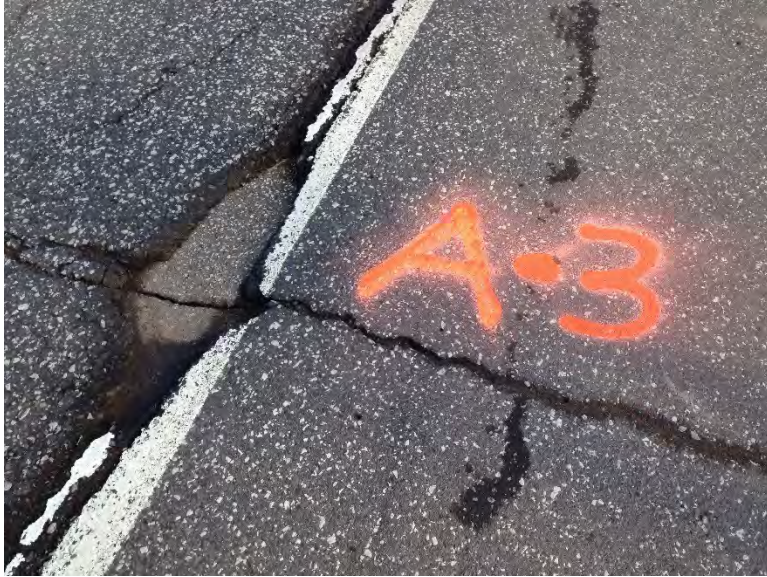
Figure 3.3 Pothole A-3 prior to Patching (After Cleaning).

Pothole A-3: This pothole was located along the shoulder joint. The pothole lies along an existing longitudinal crack in the overlay with a reflective transverse crack crossing through the pothole as shown in Figure 3.3. The pothole was prepped using compressed air. The size of the pothole was 37 inches x 13 inches x 2 inches.

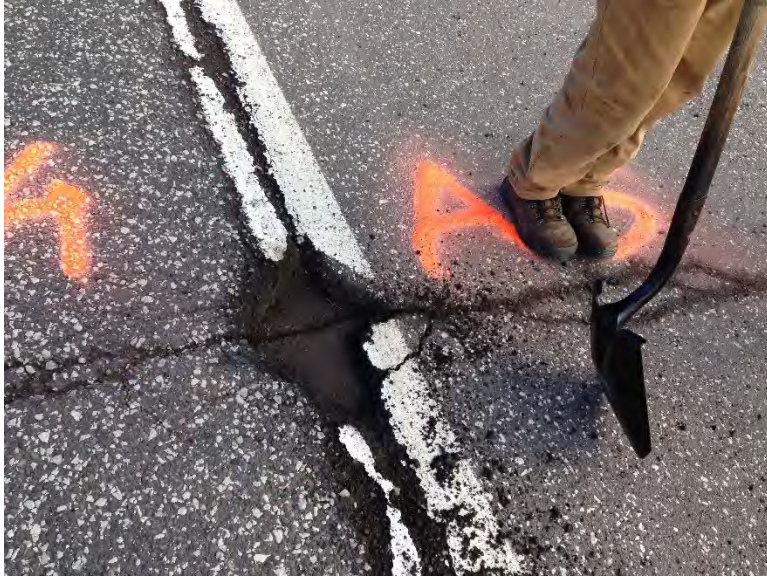
Figure 3.5 Pothole A-5 prior to Patching (After Cleaning).

Pothole A-5: This pothole was located along the shoulder joint. The pothole lies along an existing longitudinal crack in the overlay with a reflective transverse crack crossing through the pothole as shown in Figure 3.5. The pothole was prepped using compressed air. The size of the pothole was 17.5 inches x 13 inches x 1.5 inches.

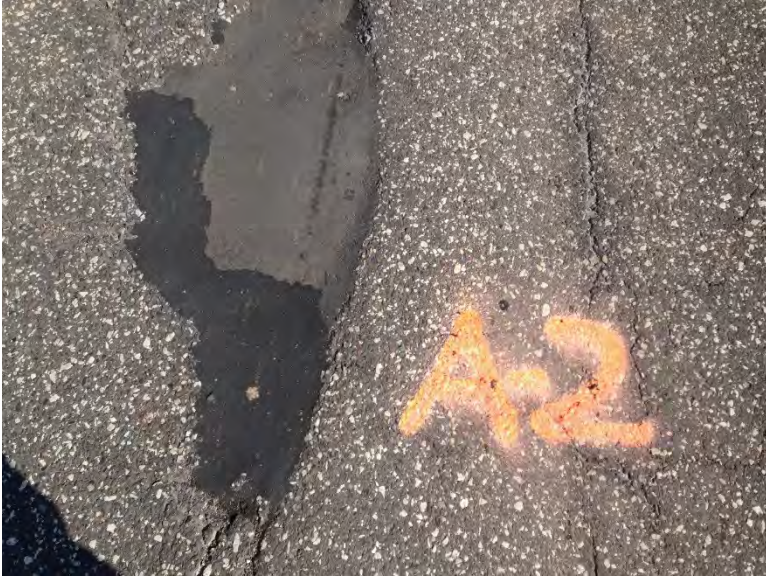
Figure 3.11 Pothole A-2 (3 Days after Patching).

Figure 3.11 through Figure 3.20 provide some photographs of the patches taken at different times to demonstrate how cold mix patches aged over time. It appears that the largest change had occurred within the first three days after patching installation while the cold mix material was still compressing under self-weight and traffic loads. Loose material around the patch edges was also removed during this time. Minimal material was removed after the initial three days.

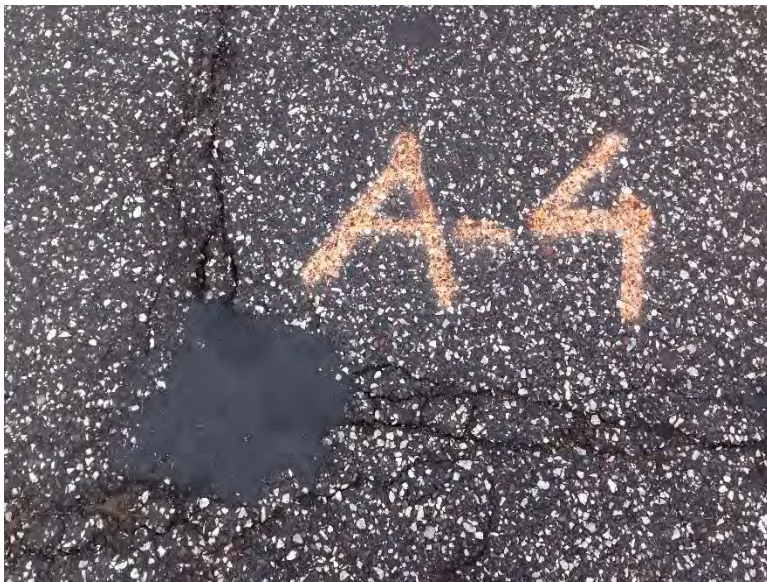
Figure 3.21 Image used for A-4 Retention Calculation (4/29/14).

Pothole A-4: Two different site visit dates were used to calculate the retention of material. The dates of comparison are April 29, 2014 (Figure 3.21) and July 9, 2014 (Figure 3.22). During that 71 day time span, the patch lost was approximately 13% of its surface area. The material lost was mostly extra patch material overlaying the existing road. The entire pothole was still patched and protected from moisture.

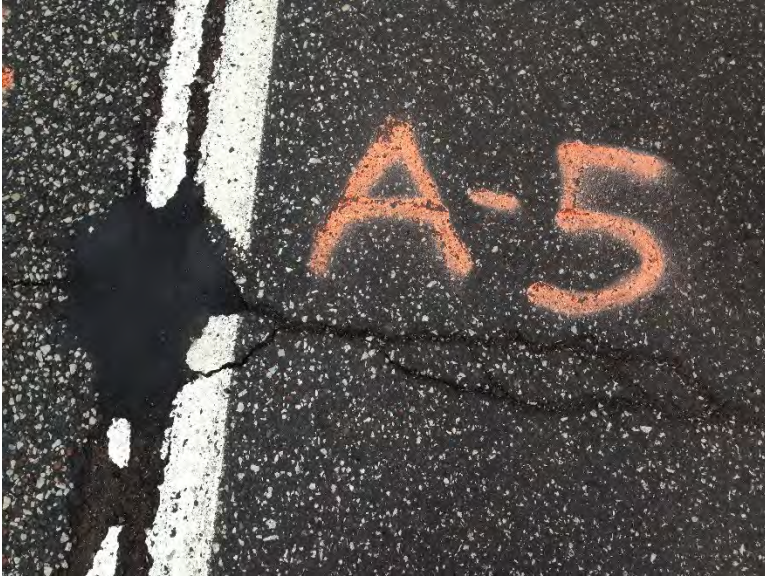
Figure 3.23 Image Used for A-4 Retention Calculation (7/9/14).

Pothole A-5: Three different site visit dates were used to calculate the retention of material. The dates of comparison are April 29, 2014 (Figure 3.23), July 9, 2014, and December 4, 2014 (Figure 3.24). Over time this patch lost a bit of material at the bottom. The total amount of material lost from April 29 to December 4 (219 days) was 17%.

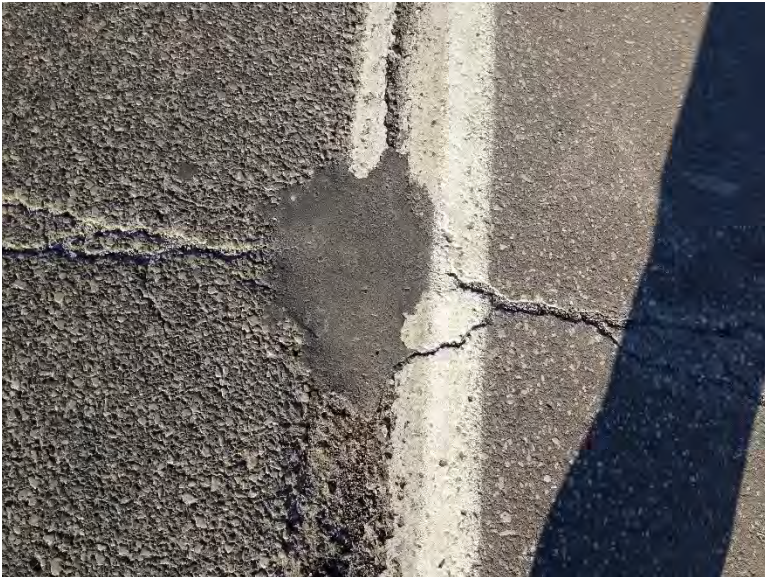
Figure 3.24 Image Used for A-5 Retention Calculation (12/4/14).

December 4, 2014, it was observed that the pothole A-5 experienced a significant depression in the material since the last visit, as well as some material loss near the bottom of the patch (Figure 3.20).

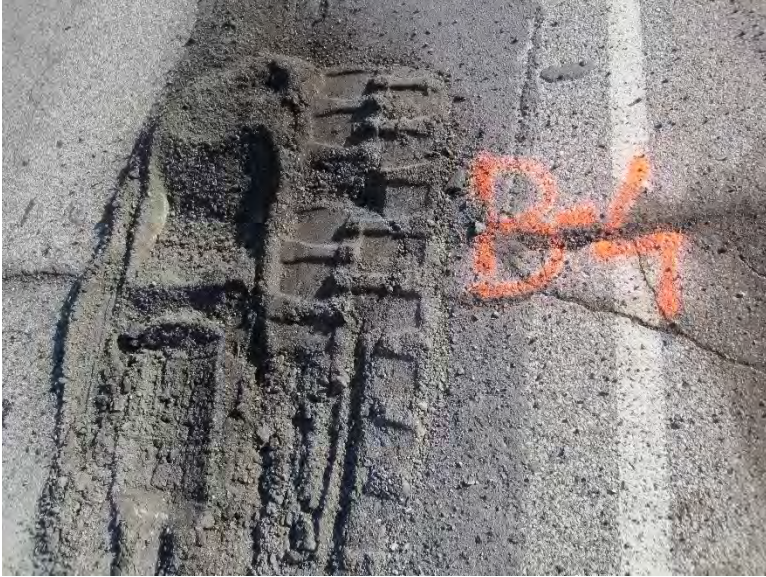
Figure 3.28 Pothole B-4 with Milling Debris Still in Place.

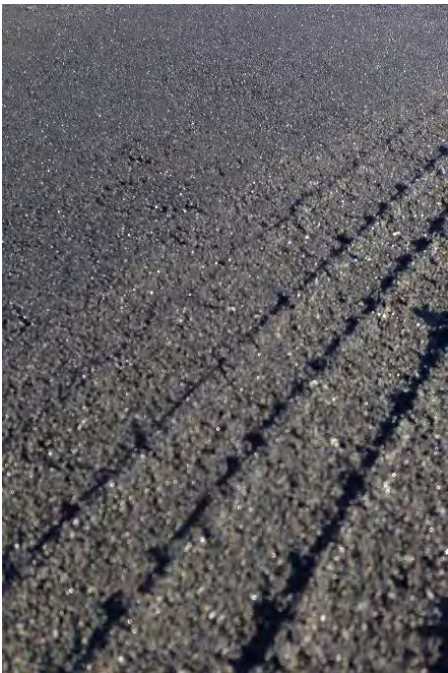
Figure 3.33 Settlement (Dishing) of Pothole B-2 an Hour after Compaction.

The cold mix patches at Site-B performed similar to Site-A. One difference at this site was the existence of significant dishing. After compaction, the potholes were flush with the roadway, however within the first hour several of the potholes had settled below the roadway surface. The depressed material is along the right edge of the crack. Pothole B-2 which suffered the most dishing was about ½ inch below the roadway surface within an hour (Figure 3.38).

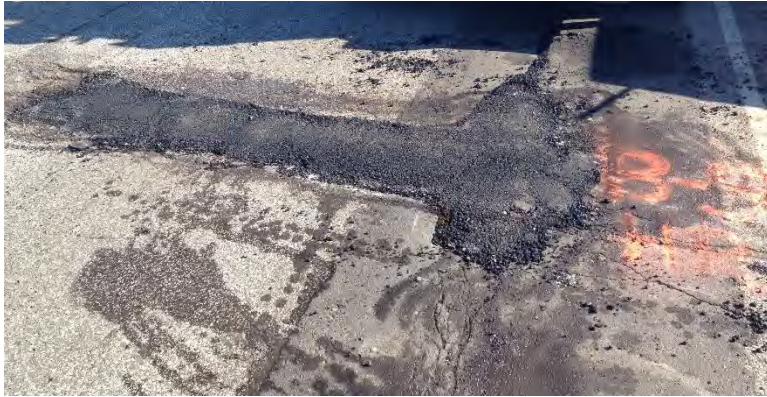
Figure 3.34 Pothole B-5 after Patching.

It may be stated that unlike the site A, all potholes were milled using a skid steer and cleaned using compressed air. Potholes B-1 through B-4 were patched using cold mix with a mix temperature of 50°F. Potholes B-5 and B-6 were patched using hot recycled asphalt. The material was 100% recycled millings from a previous project. The millings were heated to 295°F using the Stepp SRM 10-120 machine. While heating an additional 1.5 gallons of asphalt binder was added to the pug mill per 1,000 pounds of millings. Once the patches were placed they were tamped using a single plate compactor. After compaction, the potholes were flush with the roadway. Figure 3.31 to Figure 3.35 show some photographs of patched potholes. It may be stated that within the first hour, several of the potholes had settled below the roadway surface. Pothole B-2 (Figure 3.33) was about ½ inch below the roadway surface within an hour. It takes fifteen to twenty minutes to complete a pothole from milling to compaction. The patch material placed in pothole B-6 (Figure 3.35) was the first mix to come out of the SRM 10-120 hopper. It cooled more rapidly than the mix placed in B-5 (Figure 3.34) and appeared to be drier.

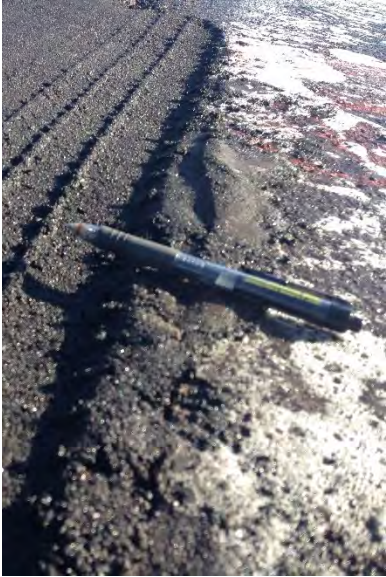
The reason for this depression was due to the depth of the patch filled. Cold mix has a small aggregate size paired with a slow curing asphalt binder. These two factors prevent the patch material from forming a stiff structure. When the pothole depth is too large, like Pothole B-2, the patch material cannot support itself. This did not occur at Site-A, because all potholes had a depth less than two inches. Dishing is common in these patches along the edges due to the inability for hand compactor machinery to properly compact along the interface. The compactor rests on the existing roadway during the compaction process preventing a complete compaction along the patch interface. Over time this area compresses under self-weight and creates the dished area shown in Figure 3.38 through Figure 3.41. After three days the patches appeared to reach their steady state compaction level. Minimal material was lost after those three days.

Figure 3.38 Settlement (Dishing) of Pothole B-2 an Hour after Compaction.

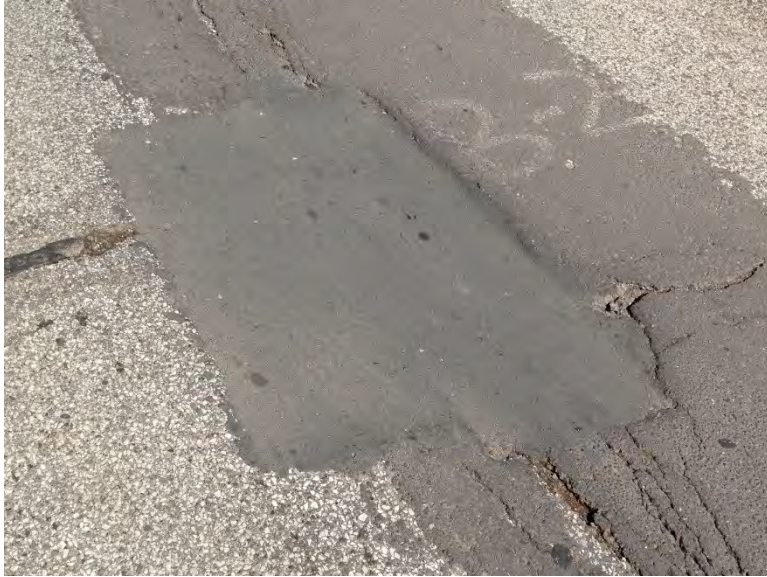
Figure 3.40 Pothole B-5 (146 Days after Patching).

An insignificant amount of additional oil was mixed into the millings to help rejuvenate the mix. For this mix 1.5 gallons of asphalt oil was added to approximately 1000 pounds of mill tailings. The result was a patch material that aged and oxidized at a rapid rate. This aging is visually apparent over time as shown in the Figure 3.42 to Figure 3.48. Raveling was a common distress due to the aged binder and significant material was lost along the edge and surface of the patches over time.

The placement of patch material actually facilitated further damage to the roadway. The damage occurring appears similar to pumping action that is common with concrete panels. As traffic loads travel across the patch area there is not an efficient load transfer causing vertical movement of the patch material. This movement ejects water and fine material from underneath the patch and abrades the adjacent roadway. Comparing Figure 3.43 and Figure 3.44 illustrates that damage to the roadway in Patch B-5. Figure 3.47 provides a close view of this deterioration in Patch B-6.

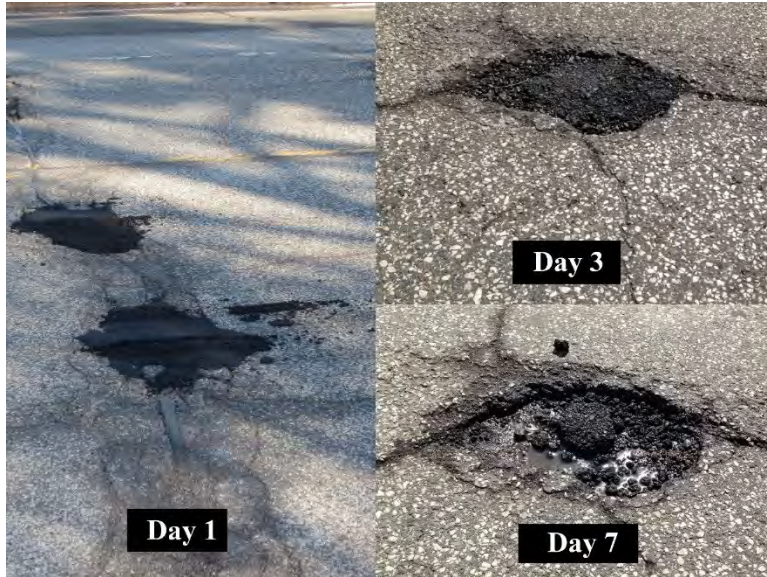
The importance of compaction is shown below in Figure 3.48. Extra hot recycled material was placed in smaller potholes in the wheel path. The potholes were not prepped before patching material was placed, and the material was only compacted under live traffic. As shown in Figure 3.48, the material was removed from the pothole after seven days. This serves as evidence that proper pothole preparation and patching material compaction can be the difference between a successful patch and a waste of resources. The last site visit conducted on December 4, 2014 (237 days after installation) showed that patches were affected by the first few uses of snow plows in the winter months.

Figure 3.48 Uncompacted Hot Recycled Material in Wheel Path.

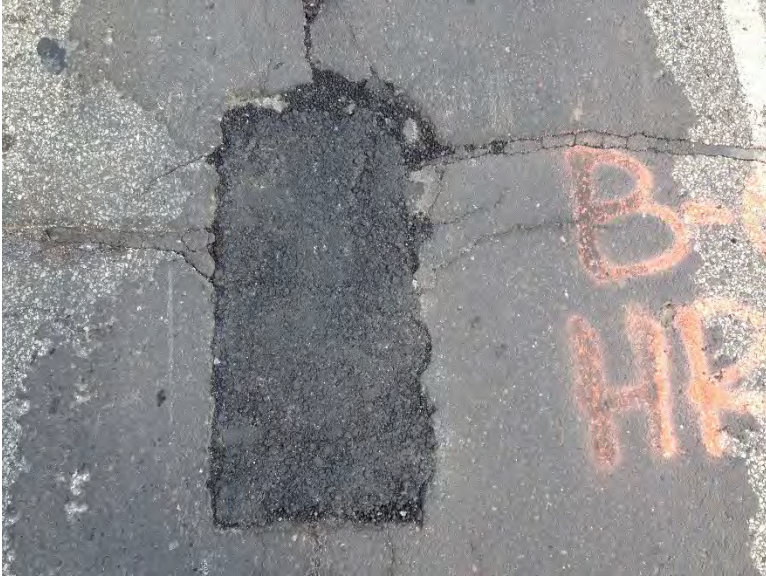
Figure 3.49 Image Used for B-6 Retention Calculation (4/14/14).

Two different site visit dates were used to calculate the retention of hot recycler material. The dates of comparison are April 14, 2014 (Figure 3.49) and July 9, 2014 (Figure 3.50). Unlike the two cold mix patches from Site-A, this patch lost a significant amount of material over time. The dry material previously discussed broke down over time and was removed from the pothole area. During this time (86 days) 19% of the patch material was lost. This percent only accounts for the material lost around the edge of the patch. The figures show that some material was also lost due to surface raveling.

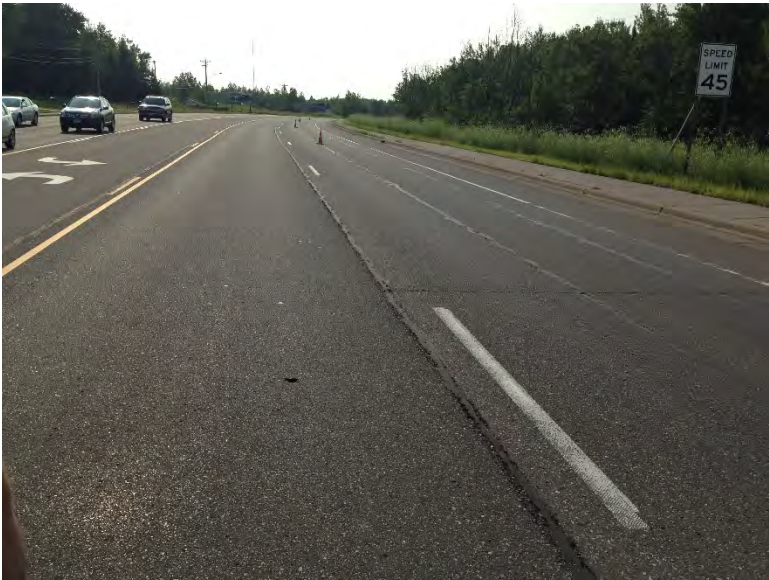
This roadway was distressed along the longitudinal joint (near centerline). The joint was a continuous crack with an average width of three inches. The crack was filled with sealer and raveling was present along the crack edges. Three locations (designated as D-1 through D-3) along the longitudinal crack were chosen to monitor the performance of hot mix asphalt patching materials.

Figure 3.55 Longitudinal Crack along Trinity Road.

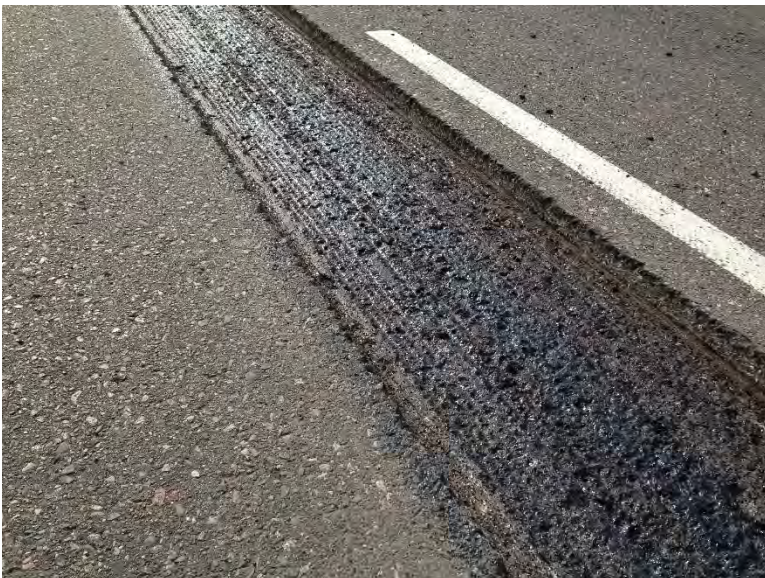
Figure 3.57 Milled Trench.

As shown in Figure 3.57 and Figure 3.58, one issue with the mill and fill operation in Site D was the tacking process used: (i) insufficient amounts of tack was applied to the milled trench and (ii) trucks placing HMA needed to place the truck's wheels into the trench in order to line up where the HMA was discharged. This led to the dirt and debris from truck wheels into the trench which covered some of the tack. Also tack stuck to the truck wheels at many locations further reduced the amount of effective tack. Without a sufficient tack coating, a strong bond at the interface of the patch will not occur, leading to possible delamination or freeze-thaw damage due to water infiltration. Figure 3.63 through Figure 3.65 provide three photographs of the patched locations taken 35 days after the installation of the patching. The patch interface at that time is shown below in Figure 3.66. Improper compaction may also lead to dished areas where hydroplaning and icy surfaces can occur.

- Complete coverage of the patch area with an approved tack material is recommended.
- When the HMA delivery vehicle drives directly in the milled area, debris from the tires covers the tack material rendering it non-functional. This should be avoided if at all possible.
- Compaction should be as thorough as possible to ensure patch longevity. Vibratory steel rollers should be employed to achieve this.

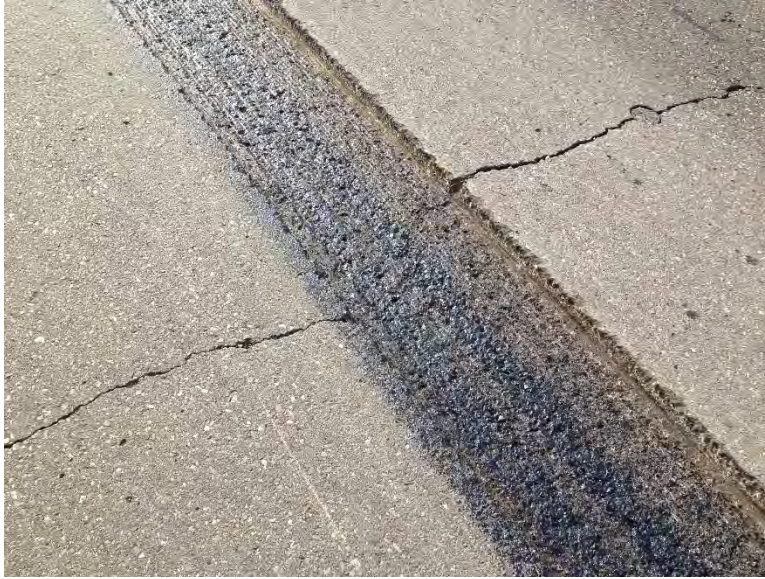
Figure 3.58 Milled Trench with Transverse Crack (Pothole D-3 Location).

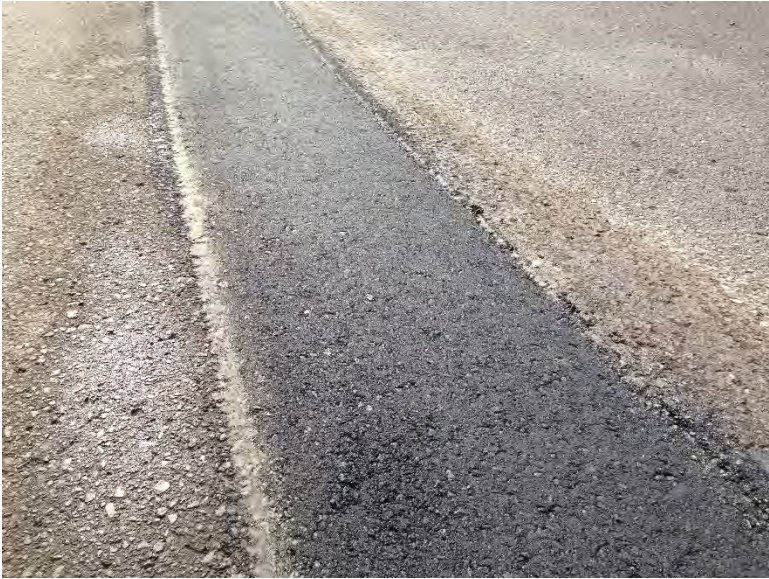
difference between excess material placement (Figure 3.59) and proper placement (Figure 3.60) is illustrated below. Placing the proper amount of material leaves a much cleaner looking product as well as reduces the amount of waste material. Figure 3.61 Shows finished patching work at Pothole D-3.

Figure 3.60 Pothole D-2 with Clean Compaction.

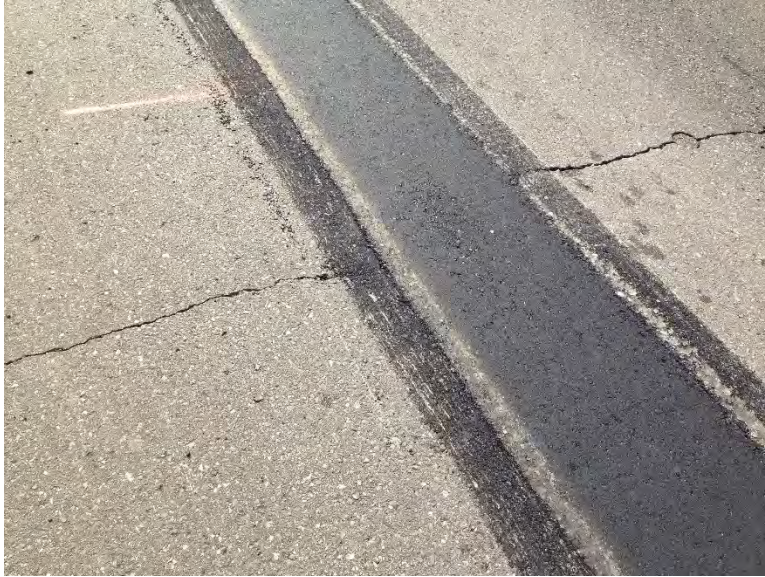
Figure 3.61 Pothole D-3 with Clean Compaction.

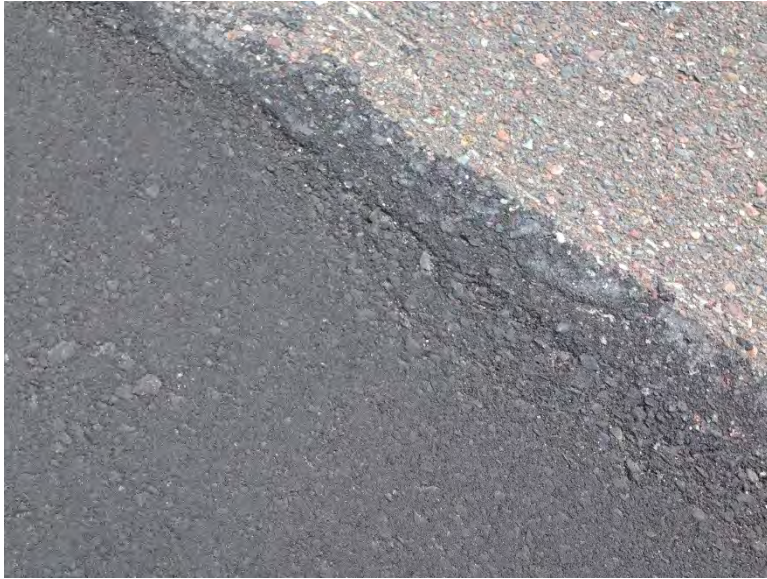
Figure 3.66 Patch Interface (35 Days after Patching).

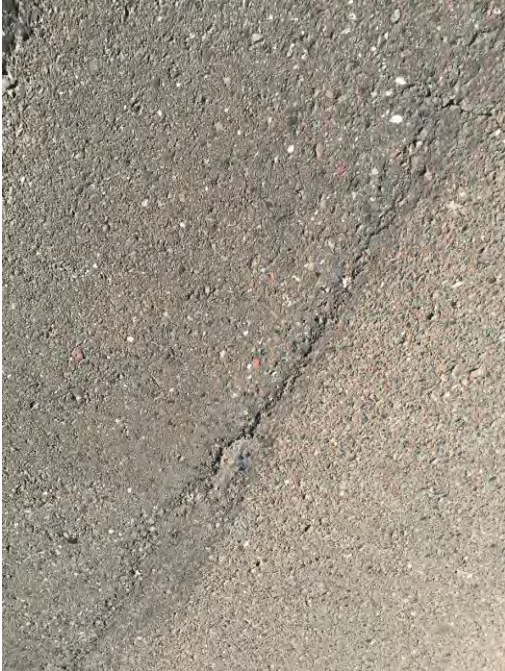
Figure 3.69 Pothole D-1 (446 Days after Installation).

Site visits conducted on July 29, 2015 and October 20, 2015 revealed that severity of the raveling did not increase in second year of service. See Figure 3.69 and Figure 3.70. It was also discovered that the cracks that had propagated through and along the edges of the patches had been sealed sometime during the summer of 2015 (Figure 3.70 and Figure 3.71). This probably helped in arresting the raveling in the year two.

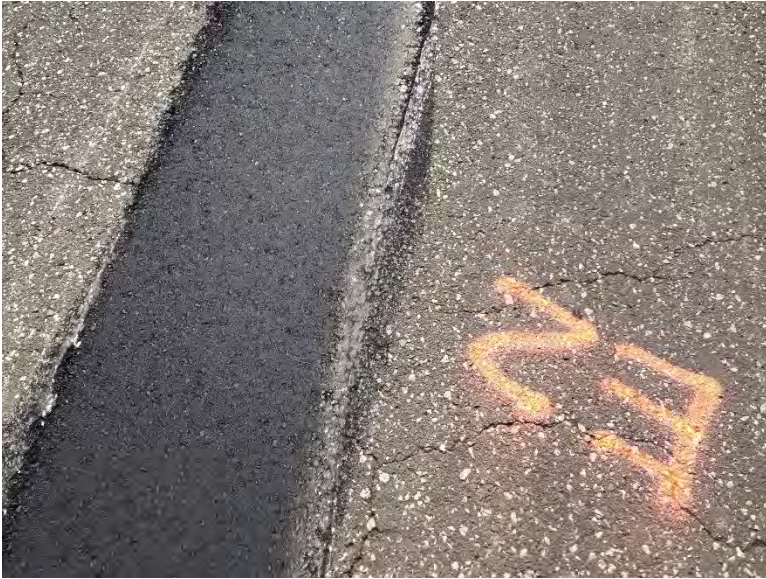
Figure 3.73 Pothole E-2 after Compaction.

Pothole E-2: This pothole was located in the non-wheel path of the passing lane. The pothole lied along a large longitudinal crack. This crack was along the joint between the driving and passing lane. The pothole was prepped with a milling machine. The size of the milled pothole was 121 inches x 20 inches x 2 inches. Several smaller transverse cracks existed and ran into the milled trench.

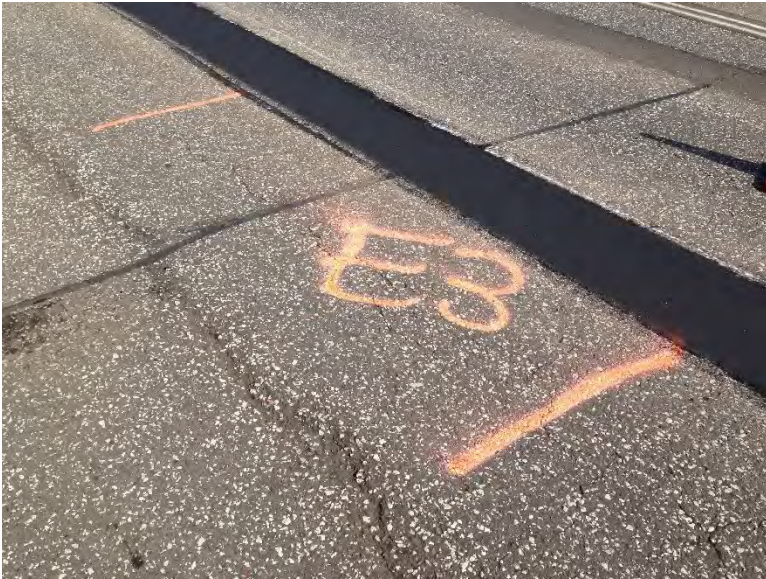
Figure 3.74 Pothole E-3 after Compaction.

Pothole E-3: This pothole was located in the non-wheel path of the passing lane. The pothole lies along a large longitudinal crack. This crack is along the joint between the driving and passing lane. The pothole was prepped with a milling machine. The size of the milled pothole was 108 inches x 20 inches x 2 inches. Several smaller transverse cracks and one larger sealed transverse crack existed and ran into the milled trench.

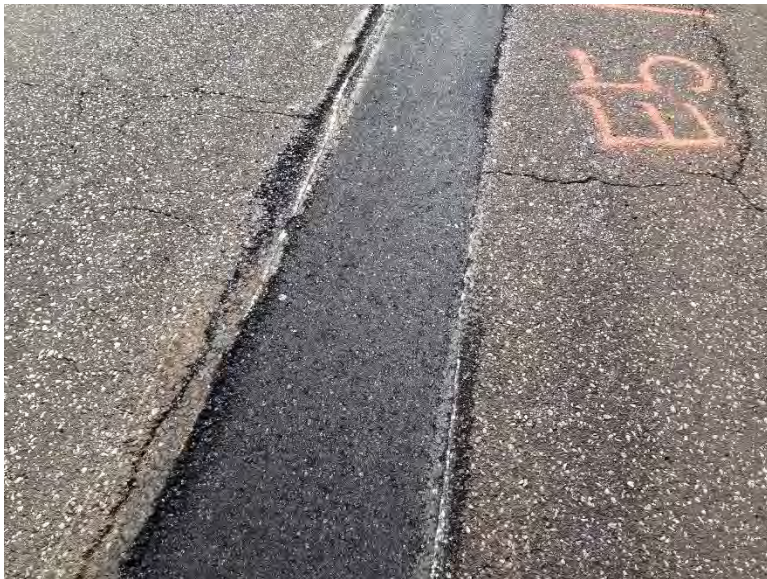
Figure 3.76 Pothole E-5 after Compaction.

Pothole E-5: This pothole was located in the non-wheel path of the passing lane. The pothole was located along a large longitudinal crack. This crack was along the joint between the driving lane and passing lane. The pothole was prepped with a milling machine. The size of the milled pothole was 121 inches x 20 inches x 2 inches. Several medium sized transverse cracks existed and ran into the milled trench.

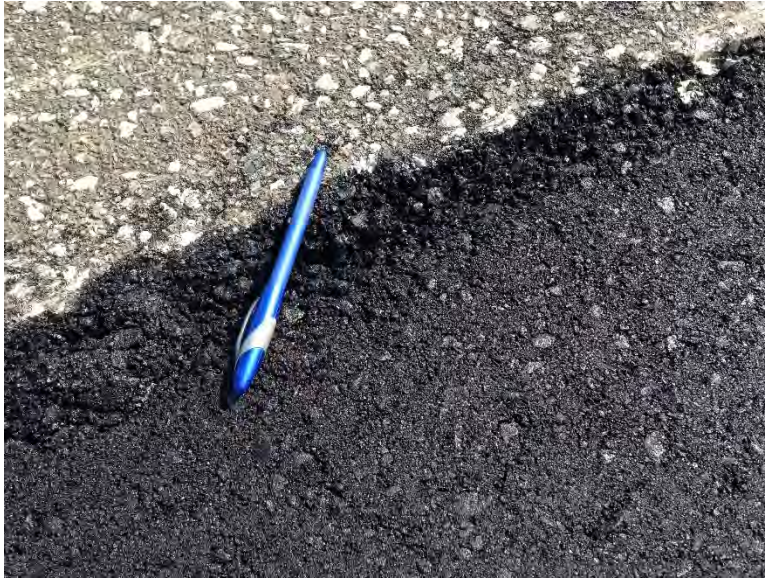
The lack of compaction issue near the interface of the pothole and roadway discussed above in Site D section also existed at this site. The issue however was more prevalent and also included some raveled material right after compaction (Figure 3.77).

Figure 3.77 Lack of Compaction and Material near Interface of Patch Material and Roadway.

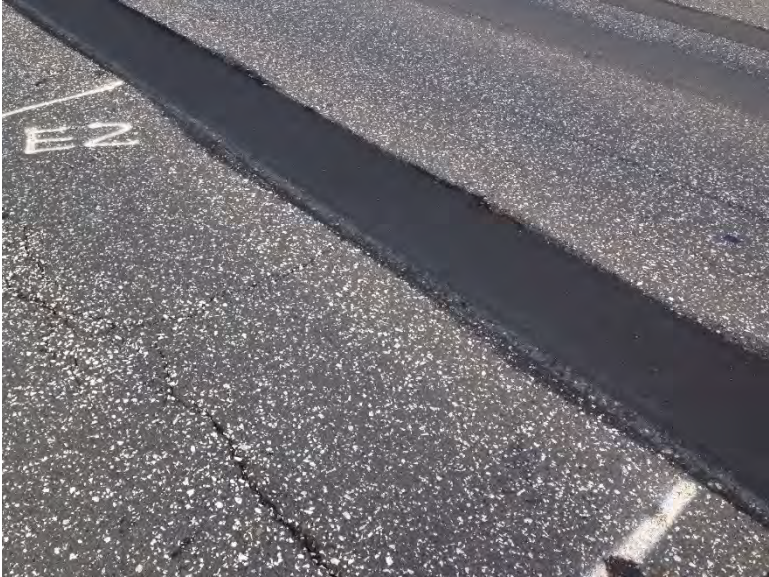
Figure 3.78 Pothole E-2 (28 Days after Patching).

Figure 3.78 through Figure 3.85 provide a visual of how HMA mill and fill patches aged over time at Site E. This site illustrated the importance of proper patching method identification as well as the need for quality workmanship during the patching process. At this site, it was common to see longitudinal cracks parallel to the patch (Figure 3.81 and Figure 3.83). For patch work to be successful, it is imperative that maintenance is performed with quality workmanship. An example of poor workmanship is shown in Figure 3.80 where proper compaction was not applied near the edge of the patch. A final site visit for

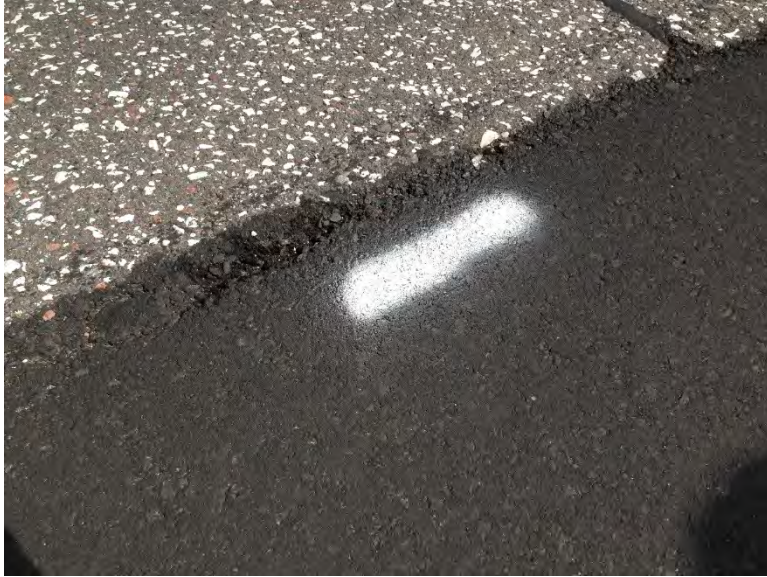
Figure 3.80 Poorly Compacted Interface (28 Days after Patching).

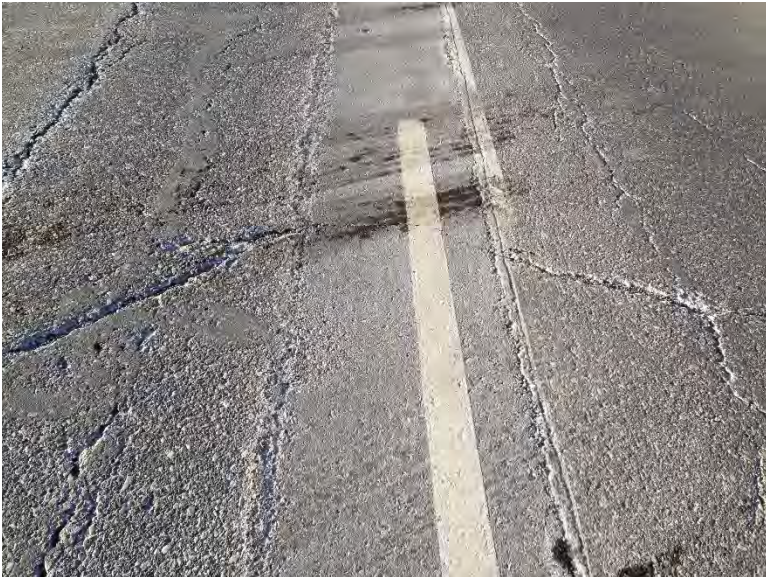
Figure 3.83 Pothole E-4 (119 Days after Installation).

the year was made on December 4, 2014. Figure 3.82 to Figure 3.85 show that a significant amount of damage had occurred to the patch material including cracks and raveling along the patch interface.

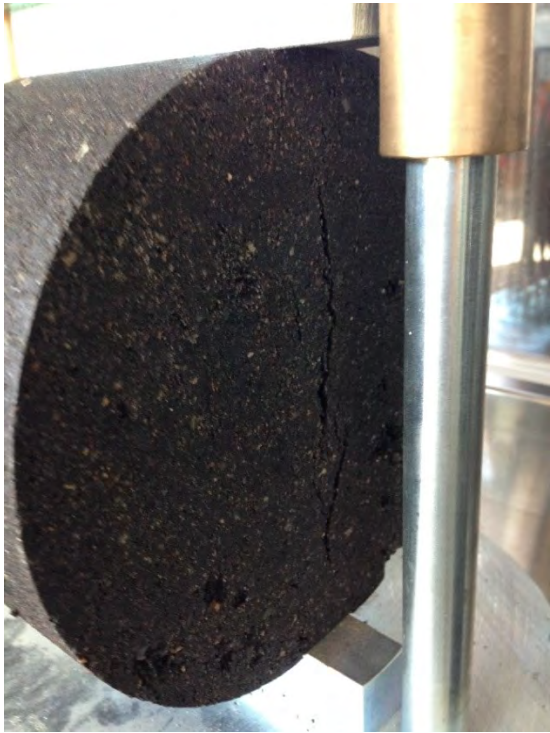
After seven days of curing, samples were tested for their indirect tensile strength. The test apparatus is shown below in Figure A4. Samples were placed in compression at a test rate of 25 mm/min. Data including the load, time, extension, stress, and strain on the sample are recorded for later analysis. Cracking of the samples occurs during testing and usually indicates the peak load has been reached (Figure A5).

Figure A5: Cracking of Sample due to Testing of Indirect Tensile Strength.
