Maintenance of Drainage Features for Safety

*A Guide for Local Street and Highway
Maintenance Personnel*

FHWA-SA-09-024

U.S. Department of Transportation
Federal Highway Administration

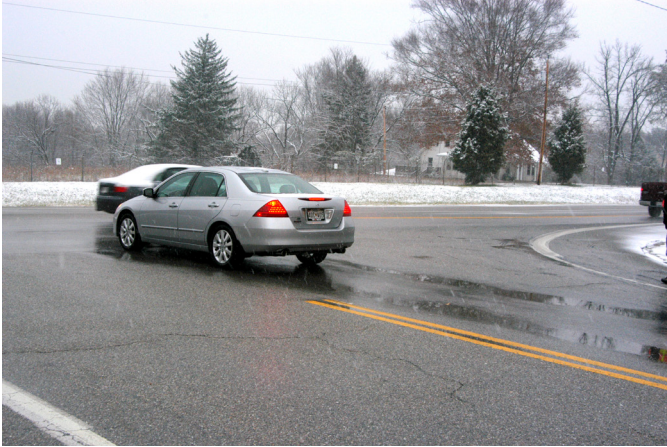
Water ponding in wheel ruts.

Rutting is caused by the wear or movement of the bituminous pavement to the sides of the wheel path. Rutting usually runs parallel to the centerline of the roadway. When wheel ruts are noticeable, they are generally deep enough to pond sufficient water to initiate hydroplaning.

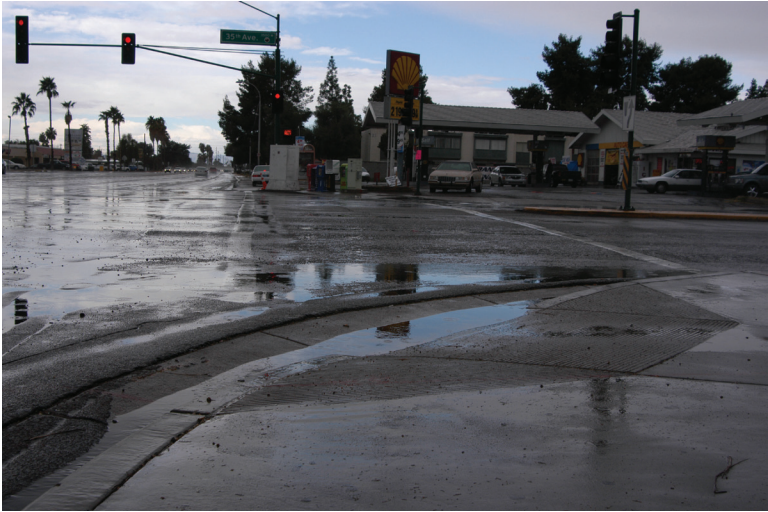
Ponding or standing water in the travel way may also cause some drivers, bicyclists, or pedestrians to divert from their desired path. Storm drains or drop inlets that have collected debris, such as leaves, can cause ponding during and after storms. Both motor vehicle and bicycle operators may choose to avoid going through

Water standing in the roadway.

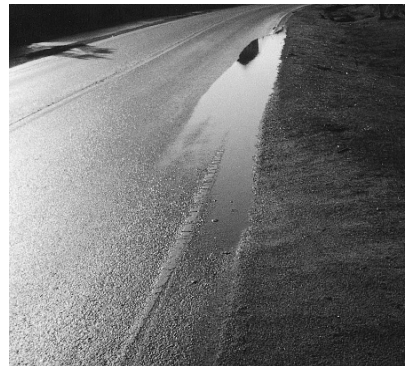
Water can pond on the outside edge of the travel way surface when debris, particularly aggregate and soil on turf shoulders, builds up. As debris accumulates on the shoulder, it raises the level of the edge, and eventually hinders run-off from flowing into side ditches.

Water ponding at the edge of roadway.

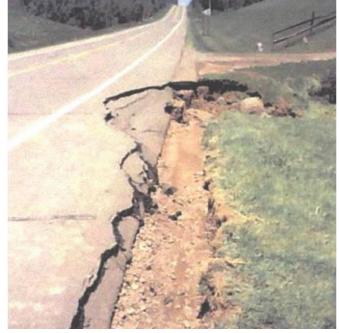
Water ponding on the edge of the pavement contributes to the deterioration of the pavement edge and the rutting of stabilized soil supporting the pavement edge, which can result in additional safety hazards. Edge drop-offs and shoulder scour are often caused when water is trapped at the pavement edge by the build-up of debris and vegetation growth.

Deterioration of pavement edge and shoulder due to poor drainage.

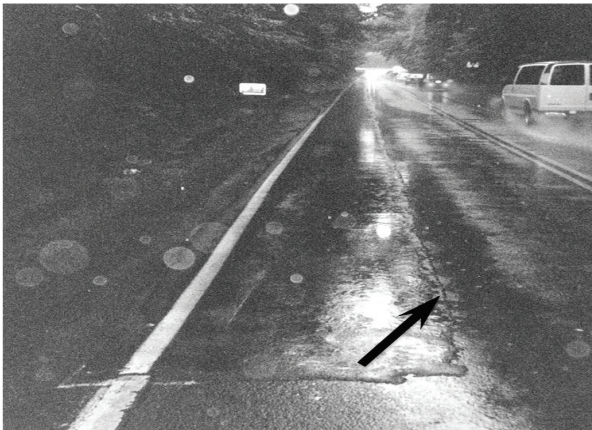
Partial overlays and pavement repairs can result in water being trapped and retained on the travel way surface. Partial overlays, either to correct shoulder deterioration or widen the roadway surface, result in a pavement edge where the overlay stops. Depending on the size of aggregate in the overlay mix and the effort taken to feather the lip into the existing pavement, water can be retained on the travel way. When the lip is along the wheel path, the thin layer of retained water can initiate hydroplaning, reduce braking ability or freeze and contribute to skidding.

The edge of this partial pavement overlay is causing water to be retained on the travel way surface.

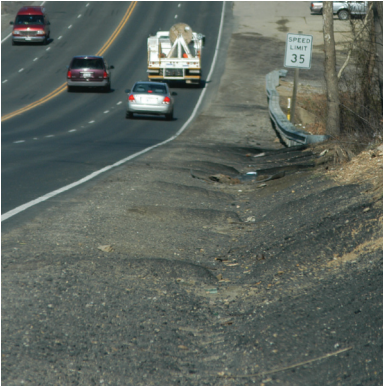
A traversable drainage ditch such as this provides space for vehicle recovery.

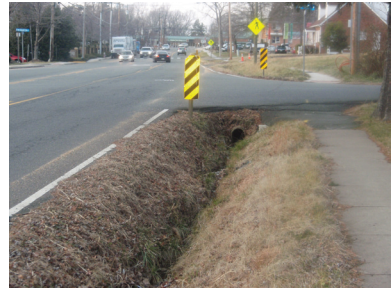
A non-traversable drainage ditch such as this is a safety hazard.

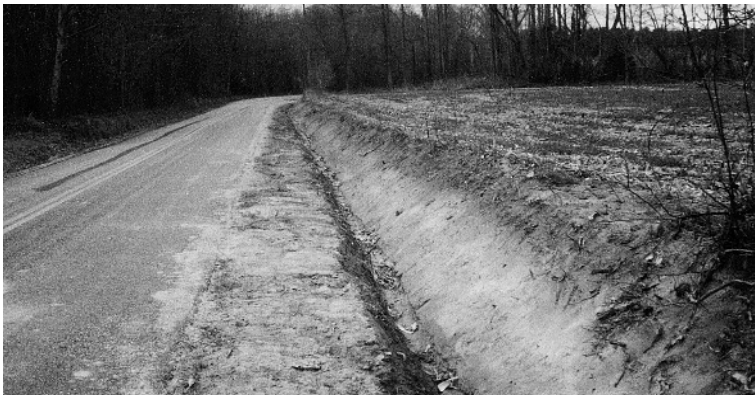
This regraded earth shoulder and ditch has a steep backslope which makes it non-traversable; if right-of-way is available the backslope should be made less steep.

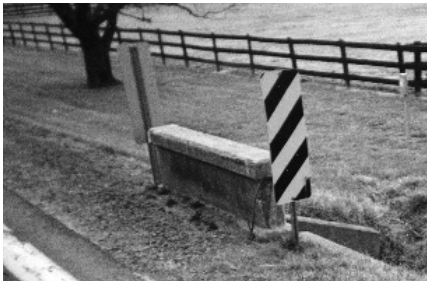
This headwall is a roadside obstacle and should be replaced as soon as possible.

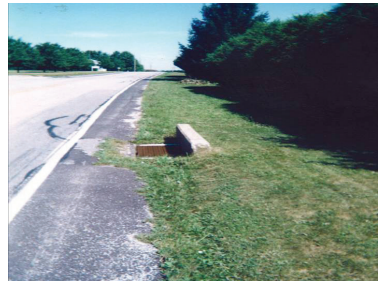
The headwall is sticking up almost a foot in a relatively flat recoverable area. It can snag a vehicle and bring it to an abrupt stop or cause it to overturn.

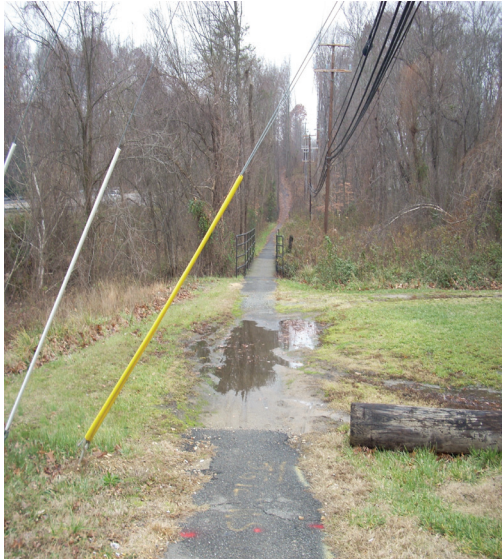
This water ponding on a ped/bike path could have been avoided by proper grading of the path.

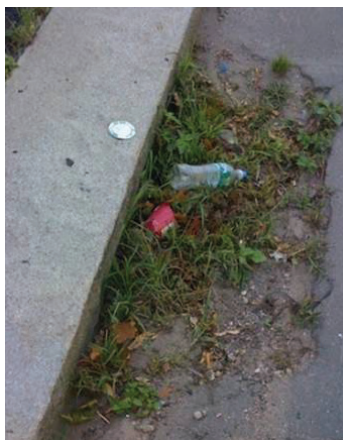
A clogged drain can easily be detected during a field survey.

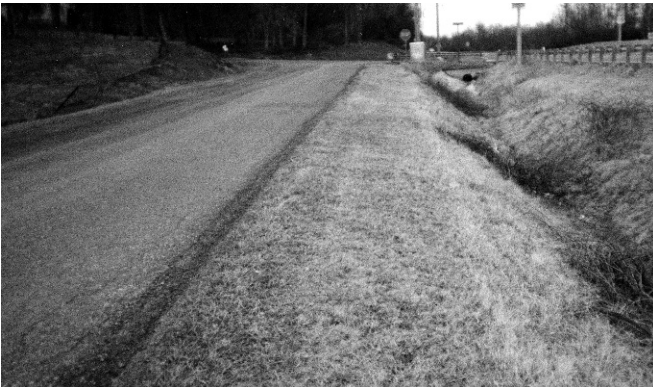
Erosion scars on a side slope can also initiate vehicle instability by tripping the vehicle's wheels and initiating overturning. Therefore, eroded slopes should be graded and seeded. When rip rap is used to control and spread the flow of water, it should have shallow inverts and be placed flush with the existing ground. Additionally, the roadside conditions should be checked to determine why erosion is taking place and the problems resolved.

Side slope erosion can cause rollovers.

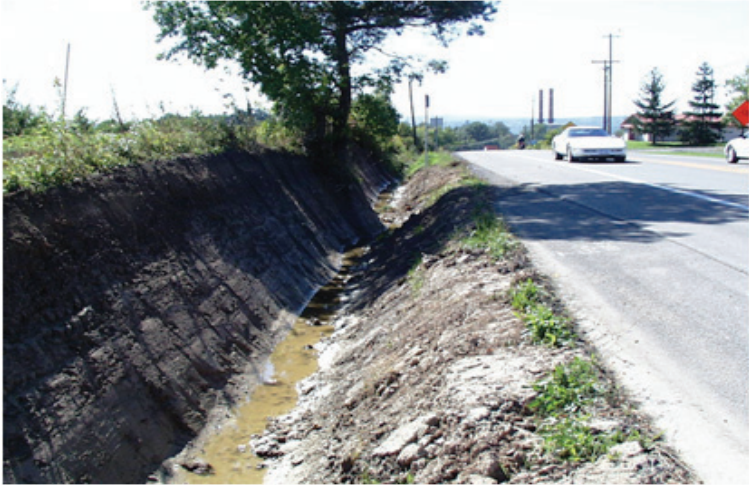
Both earth and lined ditches require maintenance to remove debris and prevent erosion that can create roadside hazards and/or reducing the effectiveness of the drainage system. It is important when repairing eroded earth ditches and shoulders to restore them to their original safety shapes. Ditch side slopes that are too steep and ditches that are too deep can initiate instability in a vehicle causing it to roll over or cause the vehicle to snag against the ditch back slope and abruptly stop or vault the vehicle into the air.

Deep ditches such as this are a safety hazard.

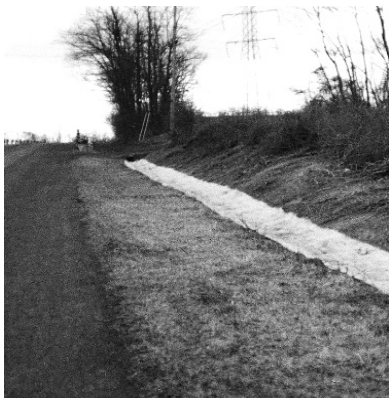
Erosion control measures such as fiber mats shown may be necessary to prevent ditch erosion.

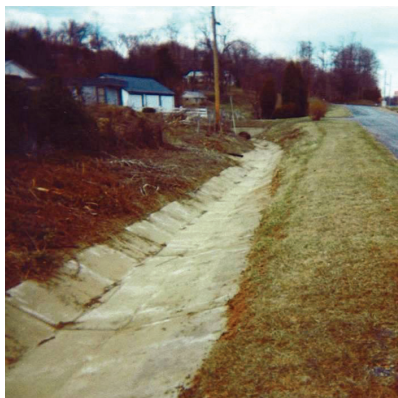
For ditches with heavy runoff, concrete lining may be necessary.

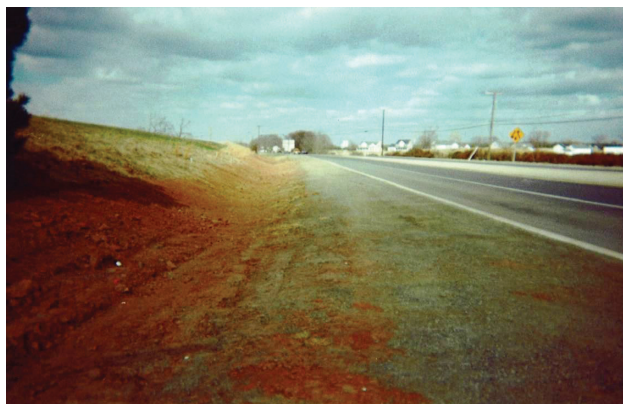
This ditch was reshaped to provide a safe recovery area for errant vehicles.

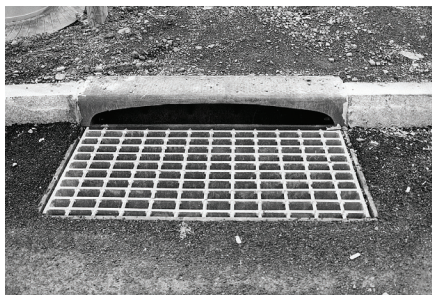
Drop inlets located in or adjacent to the path of motor vehicles, pedestrians and bicycles require grates that can accommodate run-off while preventing vehicles, bicycles and pedestrians from falling into the inlet. When bicycle traffic exists, grates should prevent the tires of a bicycle from slipping into and being caught in the grate. Therefore, bicycle safe grates should be used whenever bicycle traffic is expected. The photo below shows a preferred treatment for a drop inlet located on or near a bicycle travel way. With a flush bicycle-safe grate, a bicycle tire cannot get caught in the grate because of the cross pattern of supports which results in only small openings.

Bicycle safe grate with drop inlet.

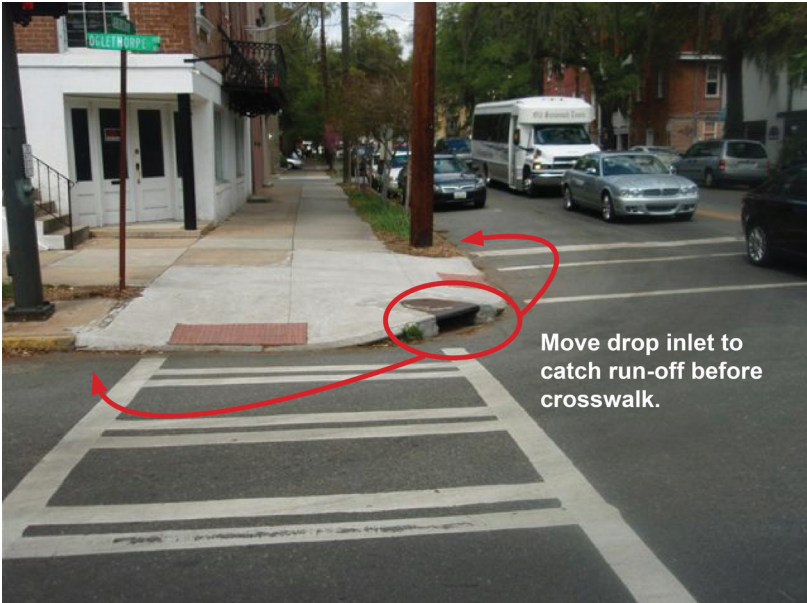
Drop inlets should not be in the path of pedestrians. To avoid run-off across a pedestrian crosswalk it is desirable to locate the catch basin and inlet before the crosswalk as depicted on next page.

To avoid run-off across the pedestrian path, it is desirable to locate drop inlets before crosswalks.

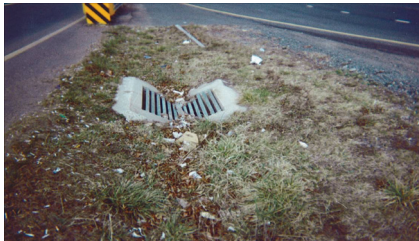
Raised roadside drop inlets, sometimes referred to as table top inlets, provide a vertical opening in their sides for large volumes of run-off and debris removal. They are usually located in low-depressed or sump areas. Raised inlets located in areas where an errant vehicle or bicycle can drive into or over them should be no higher than 4 inches above the surrounding ground. Drop inlets that extend more than 4 inches above the surrounding ground can snag the undercarriage of a vehicle in the same way a raised headwall can, causing it to abruptly stop, go out of control, or roll over. A safer drainage treatment is to use a grated inlet that is close to the ground as shown below.

V-shaped grate in median.

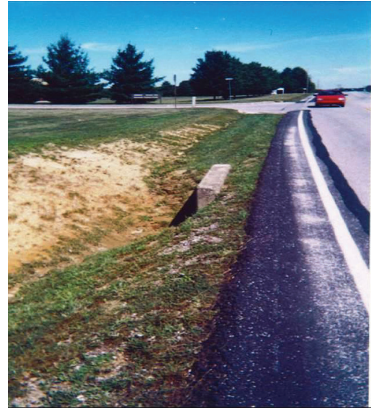
This culvert headwall is a roadside hazard.

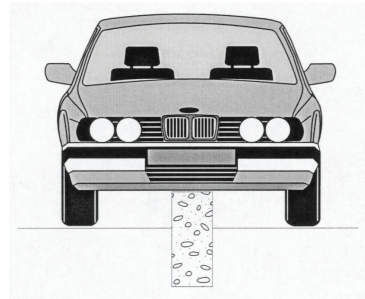
In flat areas the height of the headwall should not exceed 4 inches.

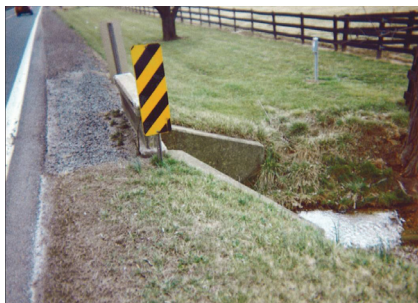
***Rigid headwall delineated with
Type 3 Object Marker.***

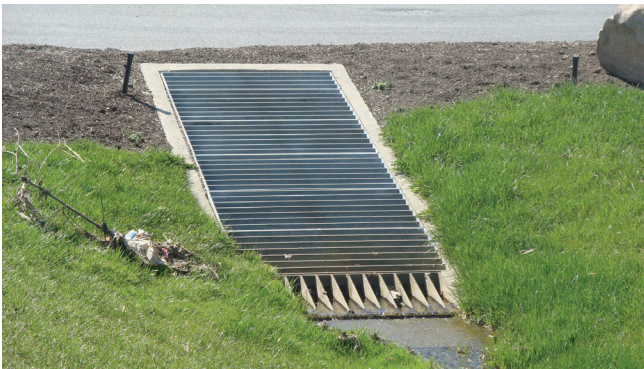
To minimize the potential of vehicle snagging on the end of a pipe, it is necessary to provide a traversable end section, ensuring that either the pipe end is cut flush with the ground line, or when used, that the steel grating is sloped flush with the surface.

Grated inlet flush with ground over a culvert end.

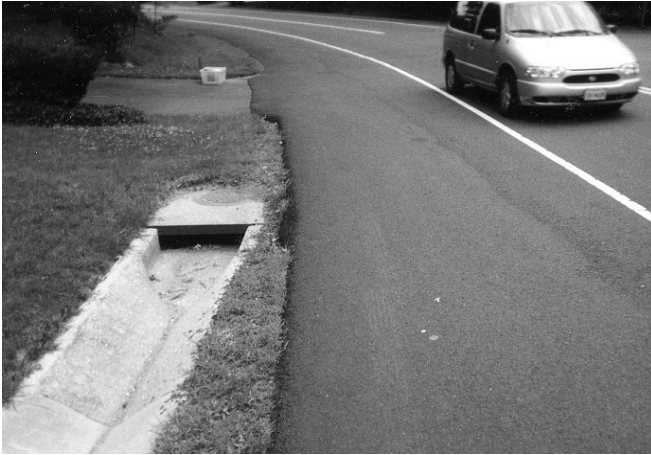
This culvert has a rather large opening which could cause a vehicle that hits it to go out of control.

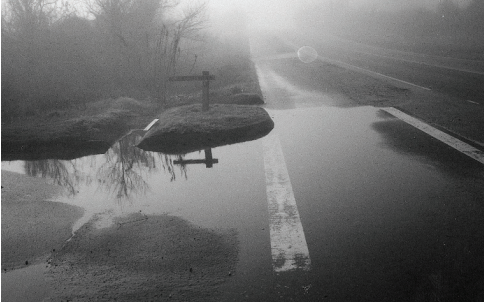
In this photo, water is ponding because the outflow ditch has silted up. Ponded water can cause drivers to leave their lane, reduce braking ability or contribute to pavement deterioration.

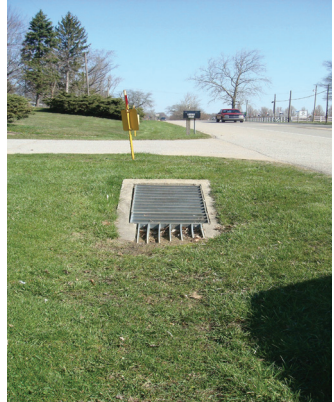
This grated inlet can be used to prevent water ponding at access points.

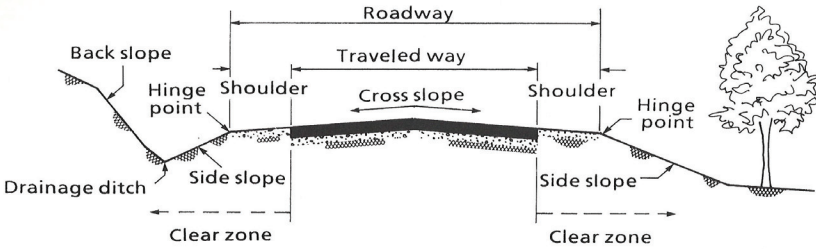
Clear zone illustration

The concept of clear zone is an approach to minimize the number and severity of crashes involving vehicles running off the road or encountering slopes that may lead to instability and overturning. Simply stated, it is a traversable area that starts at the edge of the traffic lane and extends laterally a sufficient distance to allow a driver to stop or return to the road before encountering a hazard or overturning. The traversable area would be considered safe, if there were no fixed objects, unless they are breakaway, and if the roadside geometry (either the fore slope, back slope, or ditch) was flat enough that a vehicle could safely traverse the area without tipping and rolling over. Roadside safety features include breakaway sign and light posts, and traversable drainage structures. Curbs are not considered a roadside safety feature since they can be easily mounted by errant vehicles; hence, their presence does not alter how clear zone is measured.

- Hinge Point Point where the slope rate changes.
- Clear Zone That area along the side of the traveled way including the shoulder that is available for recovery of an errant vehicle.

A safe traversable slope can be either a recoverable slope or a non-recoverable slope with a **clear run-out area** at the bottom. A **recoverable slope** is a slope on which a motorist may, to a greater or lesser extent, retain or regain control of a vehicle and recover or stop. Slopes 1:4 (Vertical:Horizontal) or flatter are generally

considered recoverable. A non-recoverable, traversable slope is a slope which is considered traversable but on which an errant vehicle will continue to the bottom. Embankment slopes from 1:3 and 1:4 may be considered traversable but non-recoverable if they are smooth and free of fixed objects. A clear run-out area is the flatter area at the toe of a non-recoverable slope available for safe use by an errant vehicle. Slopes steeper than 1:3 are not considered traversable and should not be found in the clear zone.

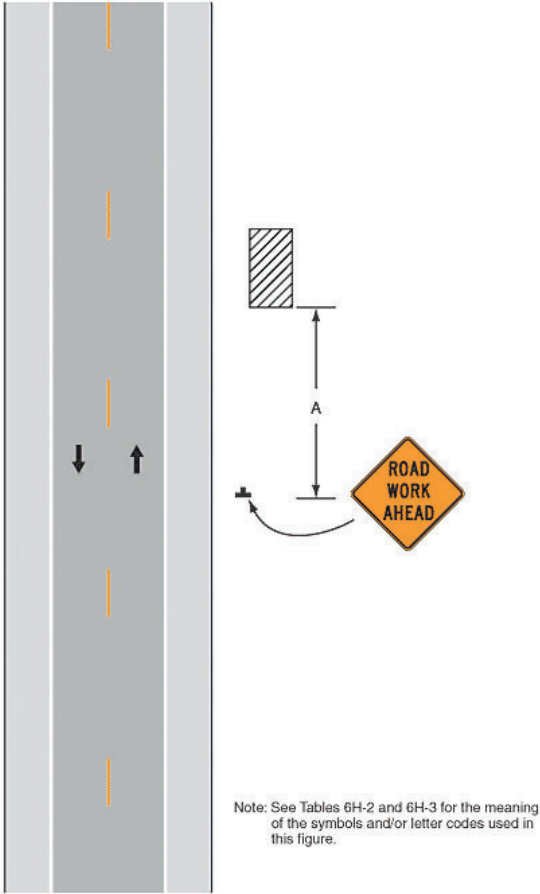
Figure 6H-1. Work Beyond the Shoulder (TA-1)

1. Typical Traffic Control Layout for Work Beyond the Shoulder

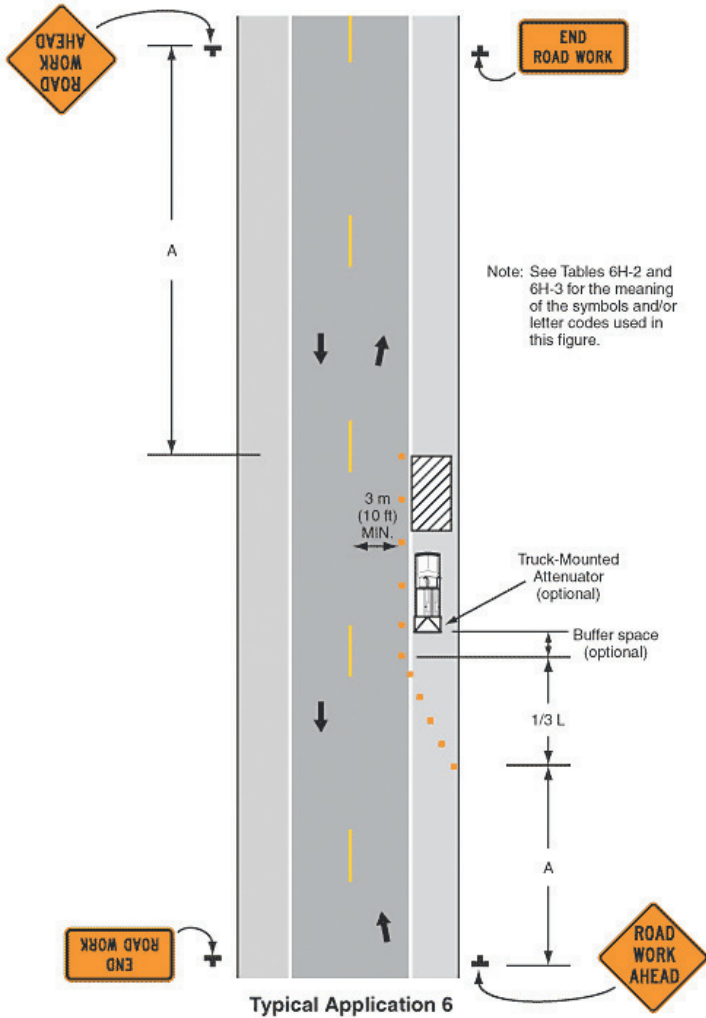
Figure 6H-6. Shoulder Work with Minor Encroachment (TA-6)

2. Typical Traffic Control Layout for Shoulder Work with Minor Encroachment

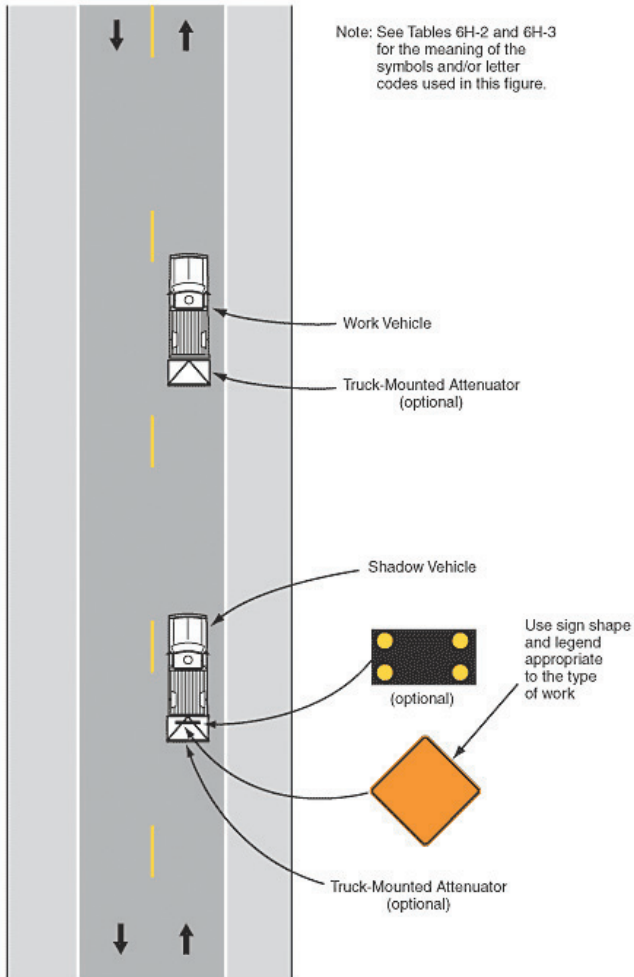
Figure 6H-17. Mobile Operations on Two-Lane Road (TA-17)

3. Typical Traffic Control Layout for Mobile Operations on Two-Lane Road
